Norwegian University
of Life Sciences

Master's Thesis 2018 30 ECTS

Jakub Glanzer Synagogue: Strategy development for revitalization of historic buildings.

2 Chapter 2: Current condition of the building

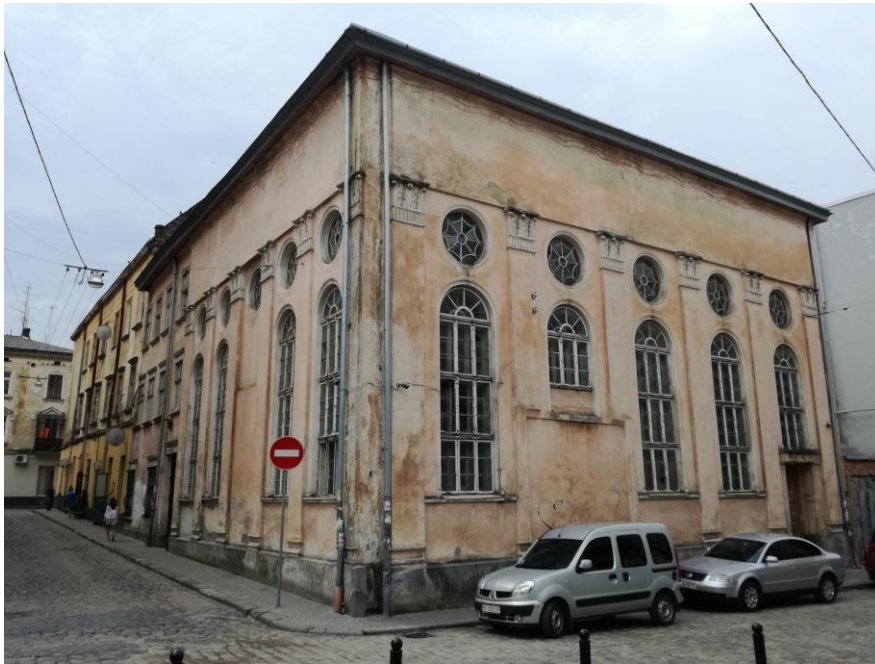
Figure 2-3: The Jakub Glanzer Synagogue. (Author, 2018).

The difference between the differences of the 1912 synagogue and the present look of the building are noticeable (Figure 2-3). Most of the ornaments are either missing or were never completed. It is also hard to estimate the scale of the damage after the pogrom of 1918.

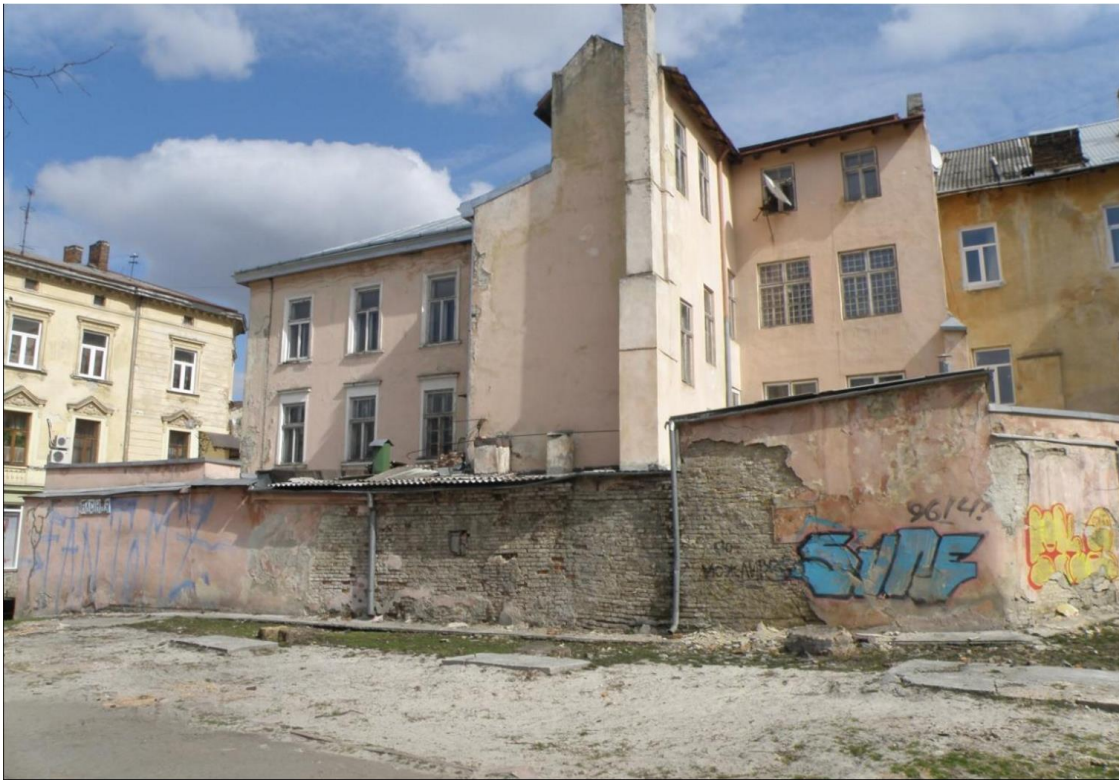
Figure 2-8: West facade. (Nazar, 2011).

The western façade photograph has been taken before the new building blocking the view of the façade was constructed (Figure C11). That way it is possible to see the whole western part of the building. On the western wall (Figure 2-8) the windows are going as far as the third floor of the building. The first three windows are reaching as far as the second floor. The two windows on the right side are going all the way up to the third floor. Currently, a recording studio is occupying this floor on the third floor. Moreover, the western part of the prayer hall has regular windows instead of the long and the ocular ones. No unique ornaments are found on this façade.

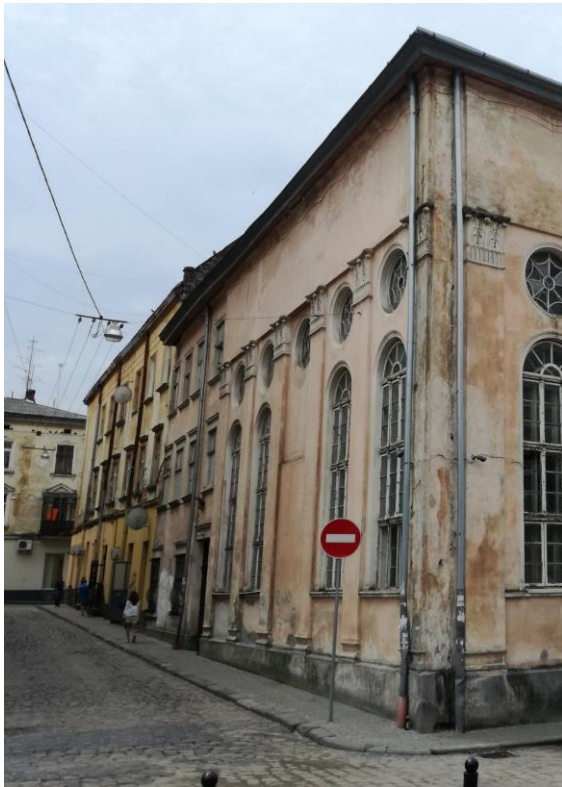
*Figure 2-9: East facade.
(Author, 2018).*

Here, one of the long windows is missing, and everything else in the prayer hall part seems uniform with the northern façade. The roof height is lower than that of the neighbouring building (Figure 2-9). On the left side of the first floor there are only two windows that are bigger than the one's above.

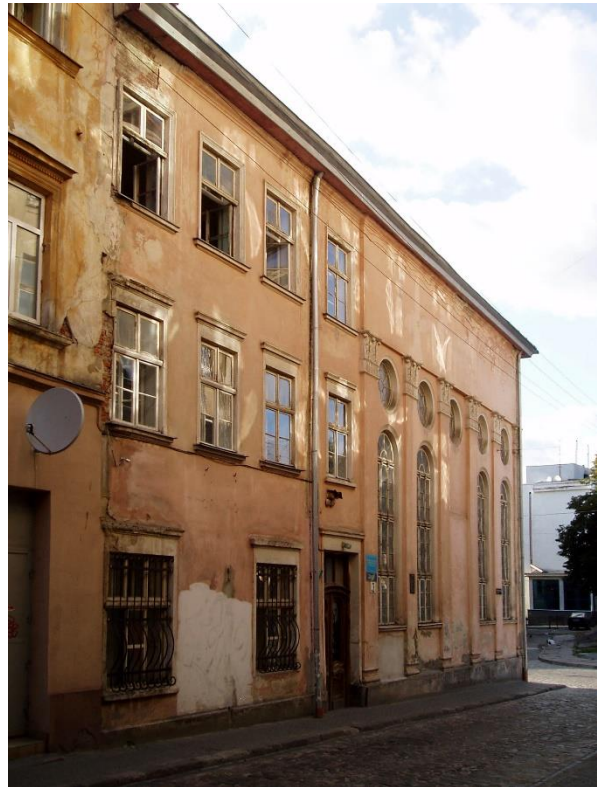
*Figure 2-10: East facade. Building transition.
(Nazar, 2011).*

The eastern façade consists of two parts of the building (Figure 2-10). The prayer hall part on the right side, and the part on the left side. The prayer hall is direct to the right of the main entrance, and everything above and to the left of the entrance stretching all the way to the second floor is office area and multipurpose room area.

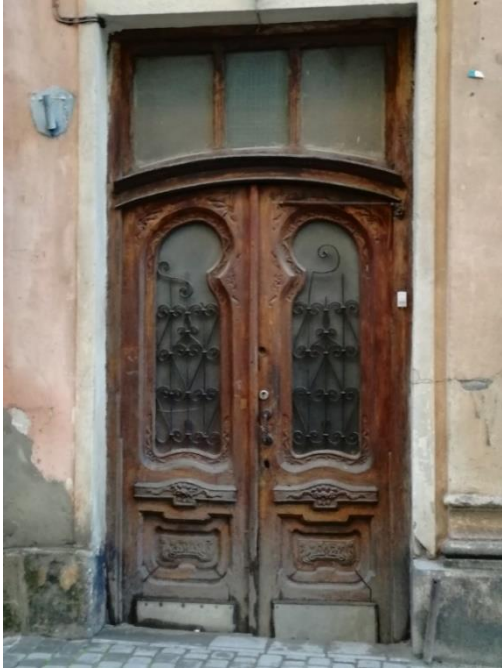
*Figure 2-11: Main entrance door.
(Author, 2018).*

The main entrance to the synagogue is located at the eastern facade at Vuhilna street. The entrance is through a solid wooden door (Figure 2-11). All the ornaments are still visible on the door (Figure C1). On that side, the ground is no longer on the same level as the door.

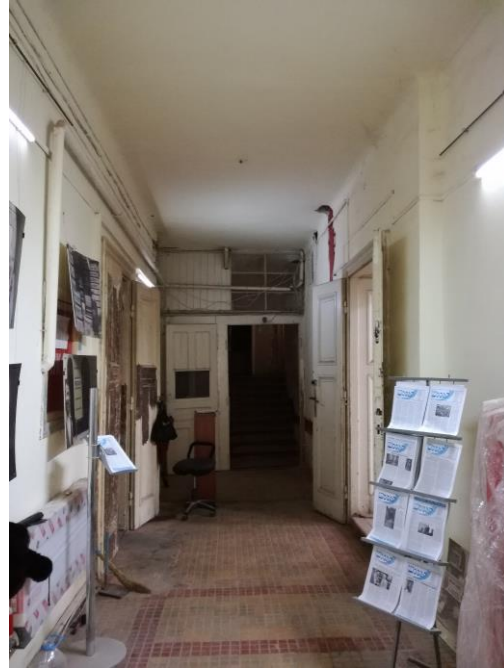
*Figure 2-12: Hallway on the ground floor.
(Author, 2018).*

The doors lead us to a long hallway (Figure 2-12). The hallway ends with a staircase and an entrance to the toilets at the very end on the half-floor above. To the right is the entrance to the prayer hall. To the left is the entrance to a section with multipurpose rooms. The height in the hallway is around 3,6 meters. The floor of the hallway is made of coloured tiles. The walls and ceiling are covered in plaster and paint.

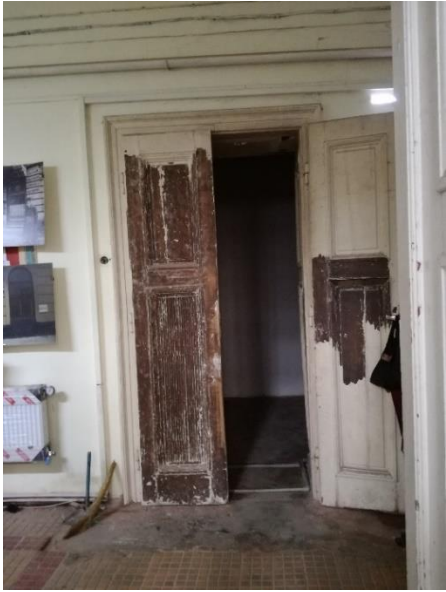
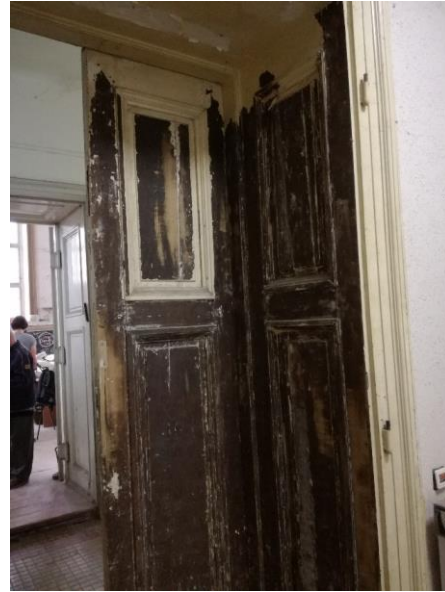
Figure 2-13: Side doors to the non-sacral part. (Author, 2018).

Figure 2-14: Condition detail of the side doors to the non-sacral part. (Author, 2018).

Further to the left in the hallway is a wooden door (Figure 2-13; Figure 2-14). On the inside, there is a series of rooms that are being used as an office or have other functions, like for example storage. Part of the ground floor is being rented out, and the rest is unused. The floor in that part is wooden, the walls are covered in plaster, and the ceiling is suspended. (Figure C36; Figure C37)

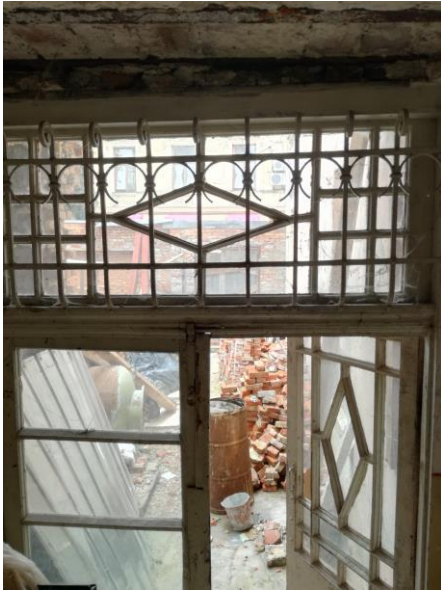
*Figure 2-18: Courtyard door. Pattern detail.
(Author, 2018).*

To give a perspective. The courtyard is a work in progress for the time being (Figure 2-18; Figure C13). The old butcher's shop is gone. Stairs leading up to the galleries are dismantled (Figure A4). What remains is the visible balcony and the old entrance. The boiler room with a furnace is strengthened after being damaged. It is visible directly on the right of the entrance to the synagogue (Figure 2-19). Behind it, there was a pathway going around the corner into the back. In the courtyard, there are some of the windows on the first floor that have been covered up with brick and plaster (Figure C10). As mentioned earlier, the entrance gate is replaced with a piece of metal sheet for the time being. Original gate is stored inside the prayer hall (Figure C15). The courtyard is not part of the evaluation in this thesis, however more pictures can be found in Appendix C.

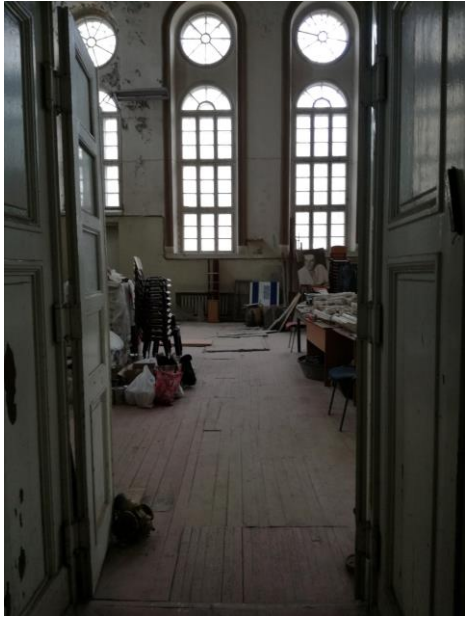
Figure 2-20: Entrance to the prayer hall. (Author, 2018).

Going to the right in the hallway is the prayer hall (Figure 2-20). The entrance has old wooden doors. A lot of the interior has been changed. First and foremost, the original paintings on the walls and the ceiling have been covered in oil paint. (Figure 2-23) Secondly, the floor has likely been replaced (Figure 2-21), as the entrance door has been trimmed at the bottom to fit the floor. (Figure C19). Thirdly, the main prayer hall is nowadays used primarily as storage (Figure 2-22), while other services like meetings and ceremonies take place in the multipurpose area on the second floor.

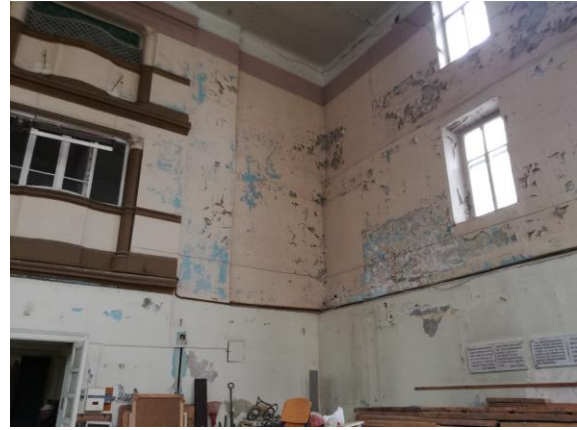
Figure 2-27: Prayer hall. Transition between southern and western walls. (Author, 2018).

At the western wall (Figure 2-28), there are the regular windows. Much of the paint is coming off. The women galleries were once built there on the inside but had to be taken down to make space for the gym (Figure A1). They connected to the staircase and continued the pattern of the current galleries (Figure 2-27).

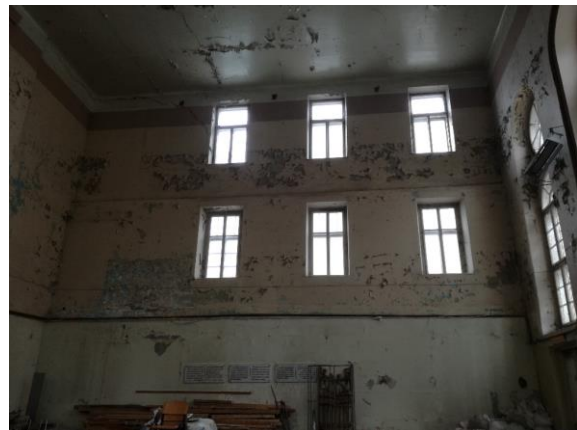
Figure 2-28: Prayer hall. Western wall. (Author, 2018).

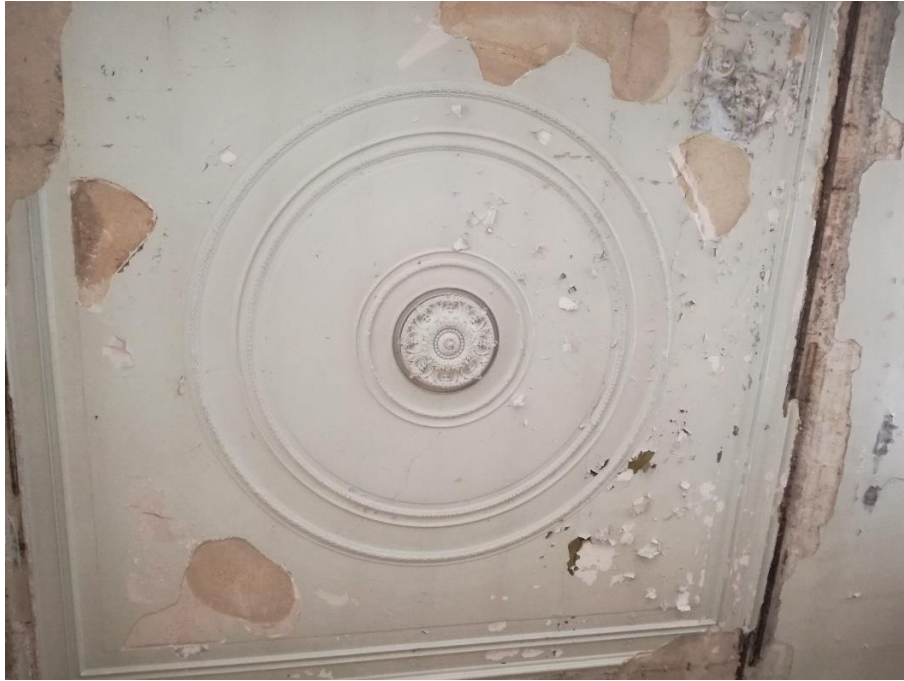
Figure 2-29: Prayer hall. Ceiling 1. (Author, 2018).

The ceiling has been badly damaged (Figure 2-29). There are a lot of visible cracks and steel beams that are uncovered (Figure 2-30). Gypsum parts of the ceiling fell off and are kept in the prayer hall. In the middle of the prayer hall, there was a place for a chandelier which is marked by the ornaments on the ceiling. The technical report suggests removal of the gypsum ornaments.

- Remove traces of ceiling decoration in the hall, to prevent further exfoliation of the gypsum decor and the oil painting of the ceiling.
- Cover the cracks in the main walls (northern wall, outside wall, western inside wall).
- Clean all the existing engineering infrastructure inside the building and under the building.
- Demolish walls and ceiling of all annexes, lay new foundations upon which annexes must be rebuilt with maintaining their original structure, height and plan.
- Execute fire protection process for all wooden elements.

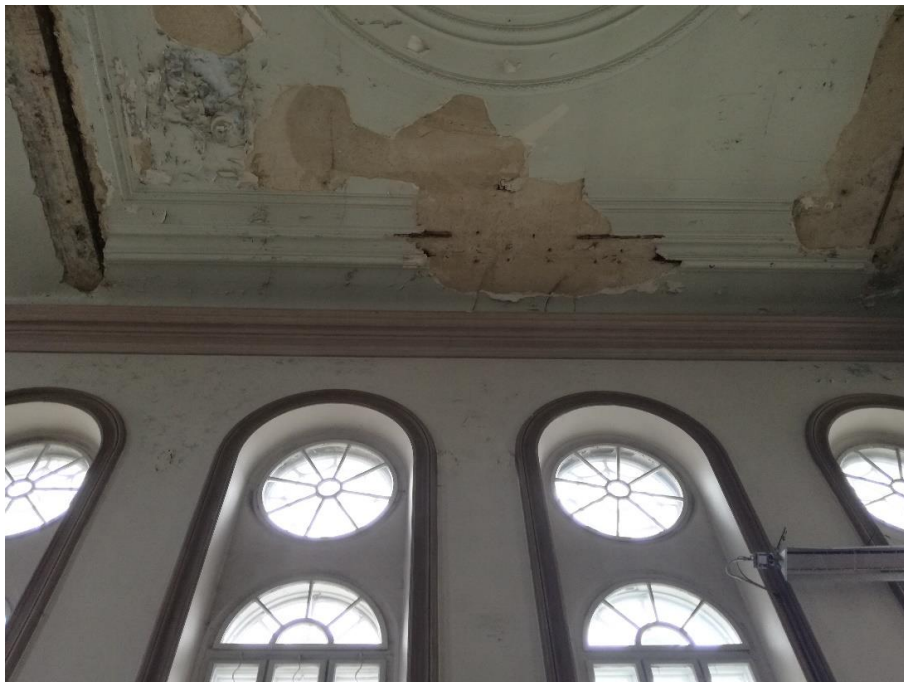
Figure 2-30: Prayer hall. Ceiling 2. (Author, 2018).

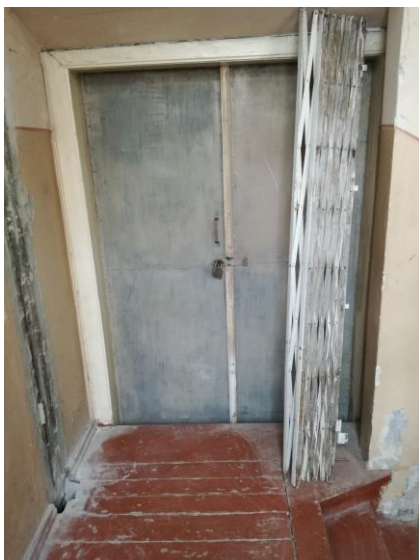
Figure 2-36: Staircase. Doors. Second half-floor.
(Author, 2018).

The door on this half-floor (Figure 2-36) lead to an outside balcony (Figure 2-37) and to an entrance to the galleries on the first floor. Old stairs outside are dismantled (Figure A4).

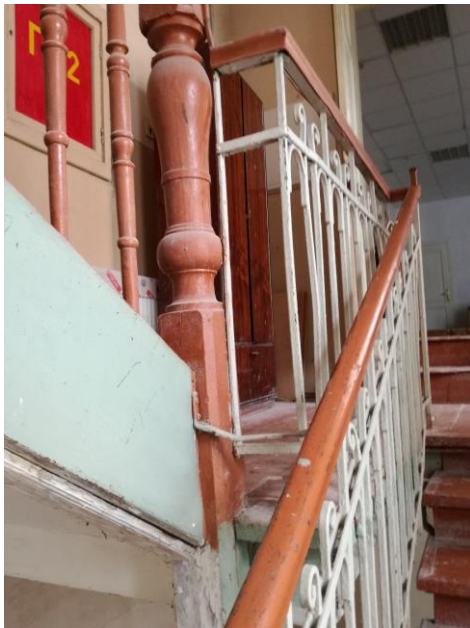
Figure 2-40: Staircase. Handrail details.
(Author, 2018).

Lastly, the material of the stairs is different than the rest of the stairs' handrail. They are entirely made of wood (Figure 2-40), while parts of the lower stairs have metal parts. The door on the top lead to the attic and recording studio.

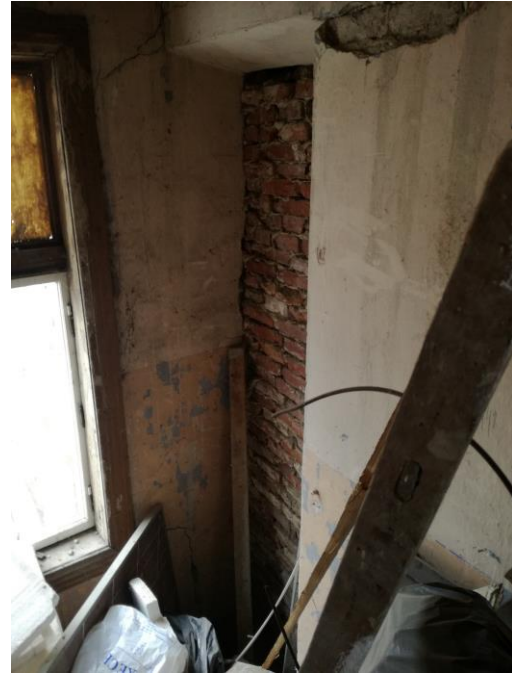
The wooden door on the second-floor lead to a room used for various purposes. Previously the room was part of the women galleries on the southern wall. Similarly, to the first-floor galleries, they lost their function and have been closed off. The stairs on the second floor going to the third have been added later (Figure 2-41). Before, there was a flat floor going all the way to the end, where there is a current half-floor (Figure A3). To the right is an old entrance to the galleries on the second floor (Figure 2-42). After the half floor has been added, only a small opening remained. On the inside, there is an old entrance that has been walled off (Figure 2-43).

Figure 2-43: Second floor entrance to the women galleries on the western wall. (Author, 2018).

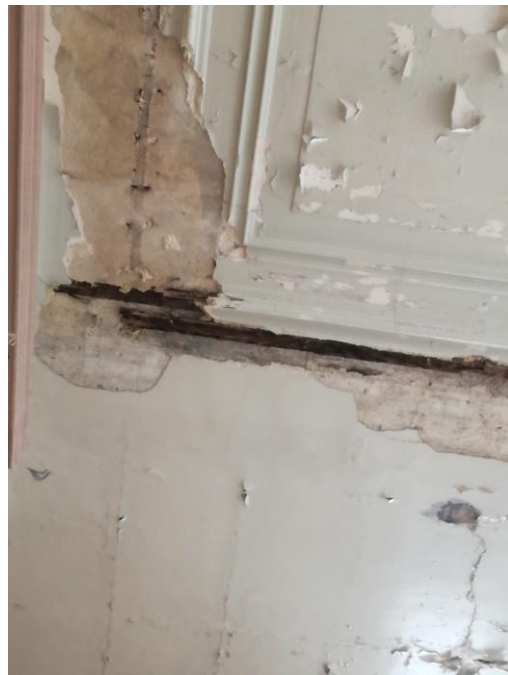
Figure C14: Prayer hall ceiling. Uncovered steel beams. (Author, 2018).

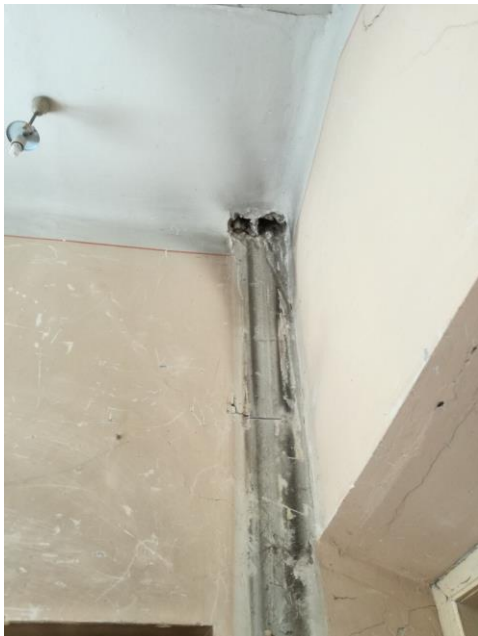
Figure C25: Staircase. Burn marks after old heating pipe system. (Author, 2018).

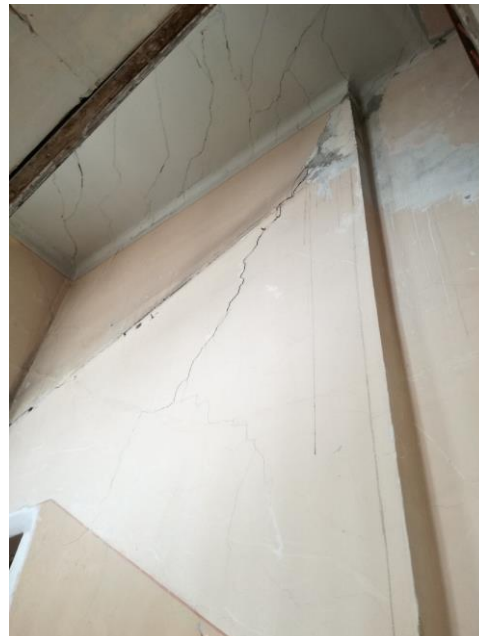
Figure C26: Staircase. Cracks on the walls and ceiling. (Author, 2018).

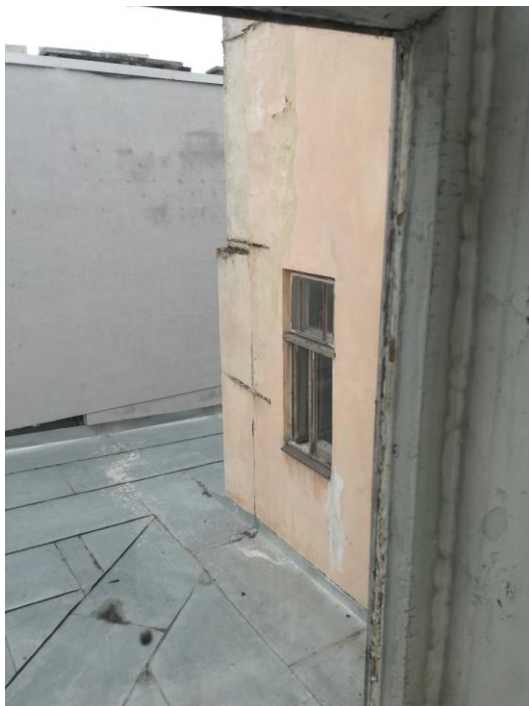
The staircase is the only one in the whole synagogue. There is no elevator, and the staircase is not fire regulated. The construction of the staircase is made of steel frame with wooden elements. On each half-floor is a radiator (Figure 2-35). Old heating pipes have been removed (Figure C28). Walls in the staircase have been painted over. There are visible cracks on the walls. (Figure C29).

*Figure C29: Staircase window. Second half-floor.
(Author, 2018).*
