Master's Thesis 2018 60 ECTS

Responses in Fish and Macroinvertebrates to Channelization and Restoration in two Arctic Rivers.

Andreas Lium

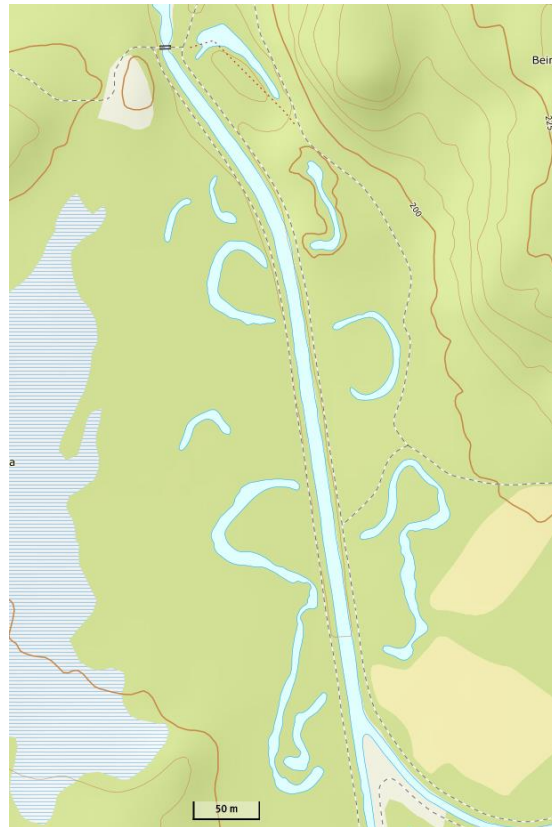
Figure 7. The channelized section of Kvernmoelva, in the southern part of the study area. Former meanders clearly visible as oxbow lakes on either side of the channel. (www.norgeskart.no).

Kvernmoelva was modified in much the same way as Salangselva, also in the 1980's. A section of the river was channelized, closing off several meanders completely (Figure 7). To my knowledge, no previous studies on the effects of channelization on fish and/or benthic macroinvertebrates has been done in this river. No restoration measures are planned or implemented.

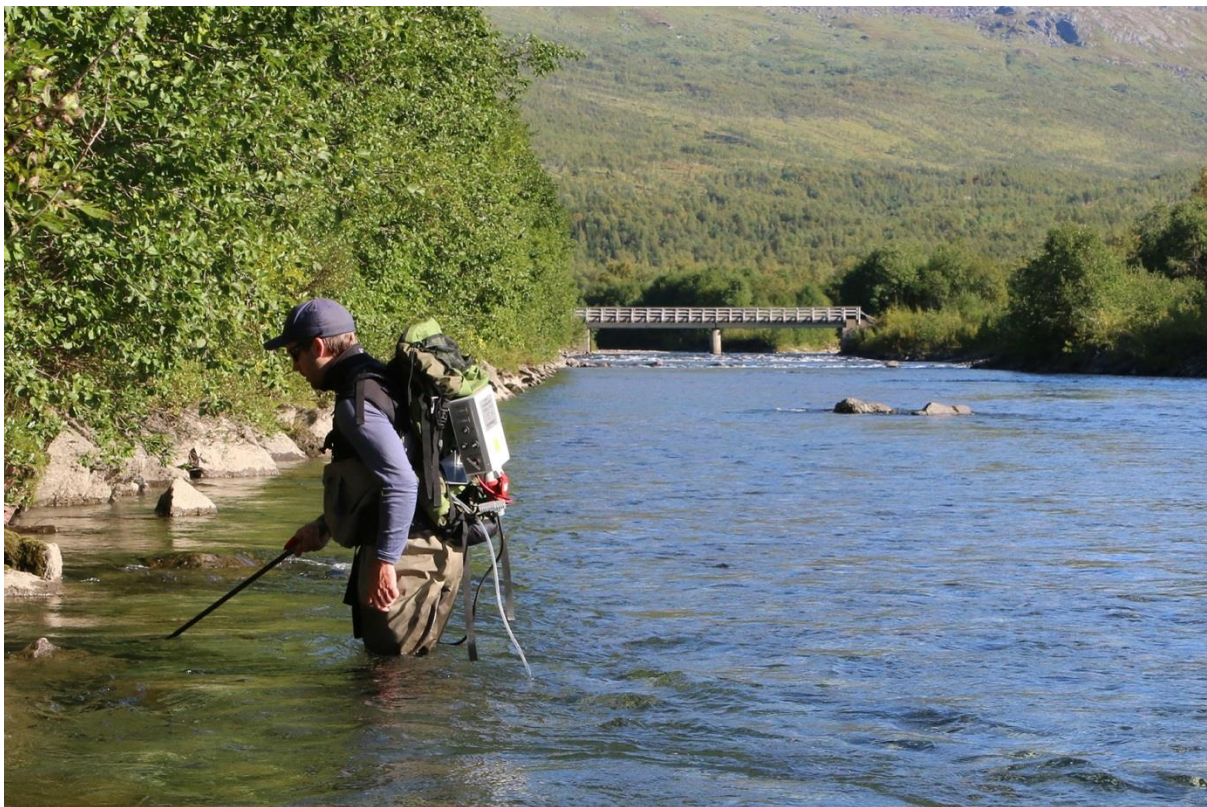
Figure 11. Photograph of electrofishing in the main river channel in Salangselva, Bones. Photo: Geir Dahl-Hansen 2017.

In the Bones area of Salangselva, the main river channel was electrofished along the bank (Figure 11). The Storøra meander and Budalsfaret tributary were easier to electrofish more thoroughly because of the shallower water. In addition to the aforementioned replication of previous studies done in the area, I also electrofished one station in the tributary Budalselva, two stations in the tributary Stordalselva, as well as one station further downstream at the northern boundary of the study area. Due to the low densities of fish to be found, only one pass of electrofishing was conducted at all stations, assuming 50% of fish present at the station being caught and registered (Strann et al. 2010). Catches were stored in a bucket until the electrofishing of one station was completed, and then measured to the nearest millimetre before being released.

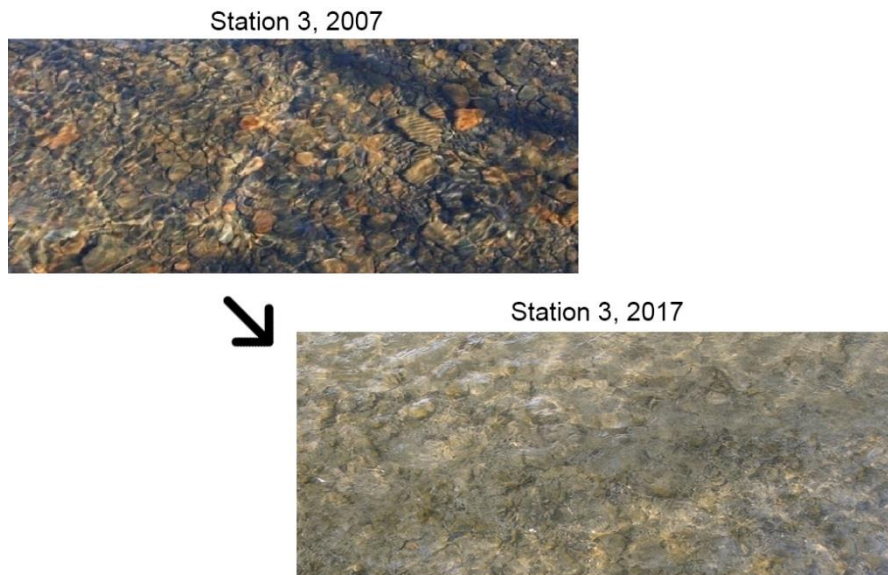
Figure 22. Bottom substrate at station 3 («Budalsfaret 2»). Photograph from 2007: Geir Dahl-Hansen.

Due to a high sediment load and low flow, fine sediment settled on the stream bottom in Budalsfaret (Figure 22; Figure 23).

photographs reveals a change in the bottom substrate for the other two sampling stations in Budalsfaret. Silt had covered most of the substrate visible on photographs from 2007. Sedimentation of fine particles degrades interstitial space habitat important to benthic macroinvertebrates (Gayraud & Philippe 2003; Harrison et al. 2007), and may cause anoxic conditions in the bottom substrate (Massa et al. 2000). This would explain the negative trend in ecological condition in Budalsfaret. No previous sampling of benthic macroinvertebrates has been conducted in the main river channel.

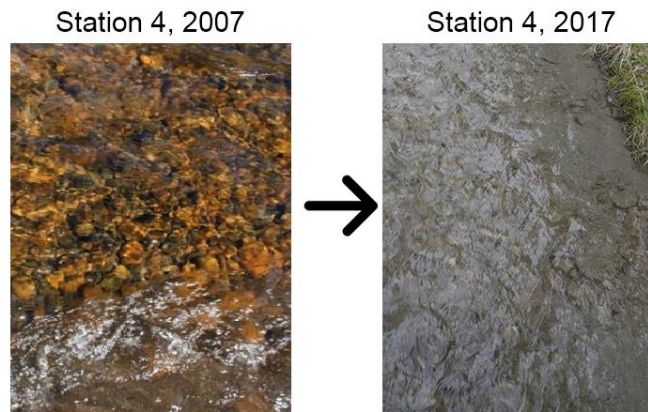
Figure 23. Bottom substrate at station 4 («Budalsfaret 3»). Photograph from 2007: Geir Dahl-Hansen.

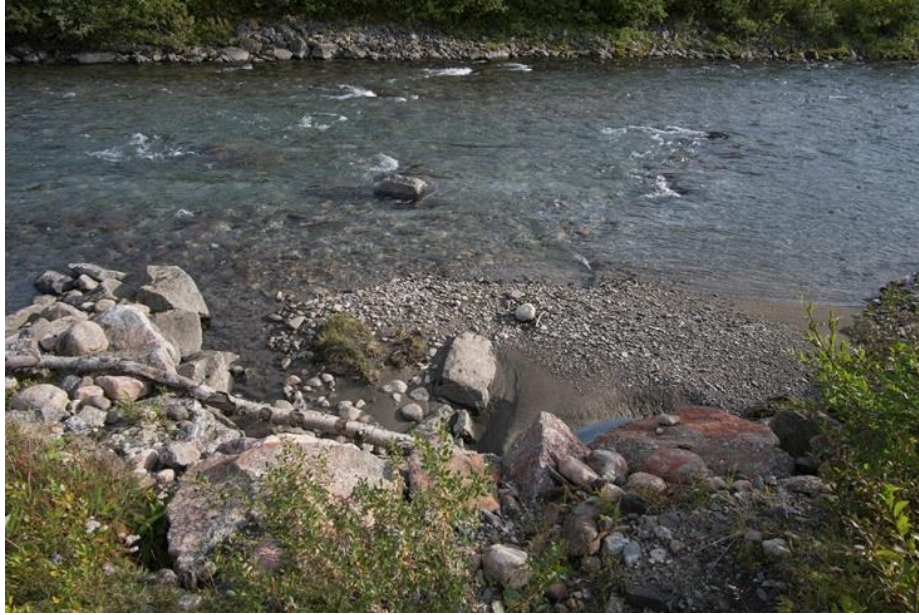
Figure 24. The intake at Gåsodden, where the intake is constructed at a 90 degree angle to the main channel. Location indicated with a «G», on the map of the Salangselva study area in Appendix C2.

Accumulation of sand, gravel and cobble is problematic when intakes are constructed at a 90 degree angle to the main channel. Turbulence leads to accumulation of sand and gravel, and effectively blocks the flow of water (Figure 24; Figure 25).

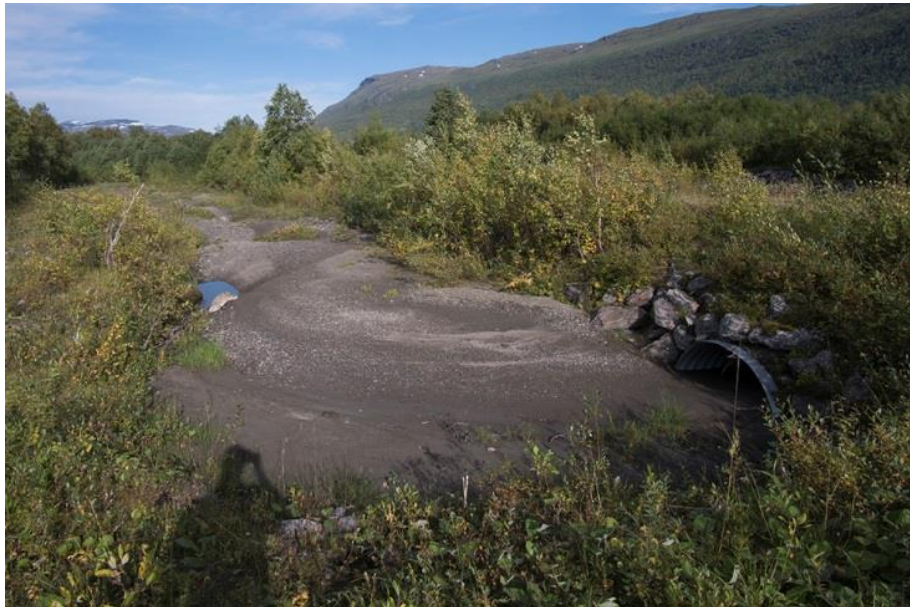
Figure 25. The reopened tributary at Gåsodden, where the intake causes accumulation of sand, gravel and cobble.

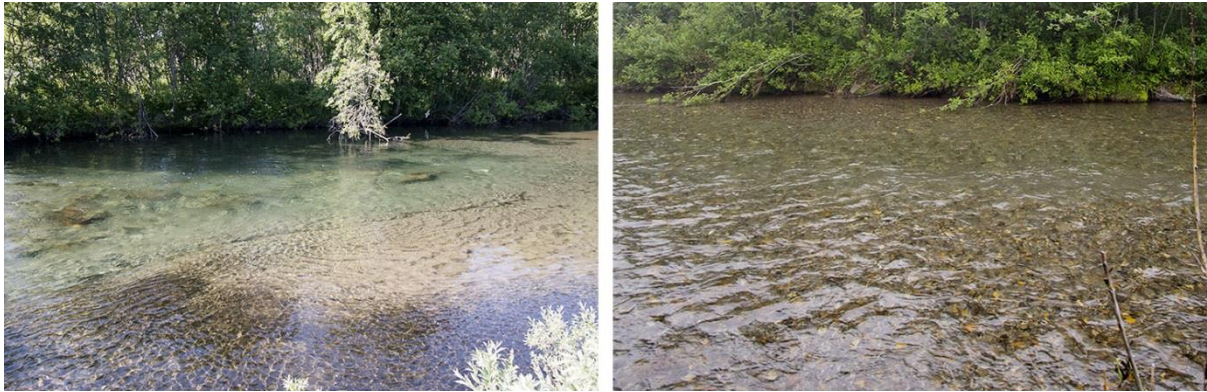
Figure 30. Scattered boulders clearly visible in a pool in the naturally meandering stretch of Kvernmoelva (left) where sand is the dominating bottom substrate grain size, and homogenous gravel bottom substrate in the channelized stretch of Kvernmoelva (right).

Most juvenile brown trout caught and registered in the Kvernmoelva study area were associated with hiding places under or between cobble and boulders. The registered bottom substrate at each station was the dominating grain size, thus the low power of the variable substrate in the statistical analysis might be misleading. Scattered cobble and boulders were more numerous in the naturally meandering part of the river than in the channel (Figure 30). In addition, fine-scale variation of the variables LWD and water velocity might have been lost during the registration of means within each station. Observations indicate that there were indeed more coarse organic material, boulders, and variations in water velocity both horizontally and vertically in the naturally meandering stretch of the river compared to the channelized stretch of the river – as would be expected.

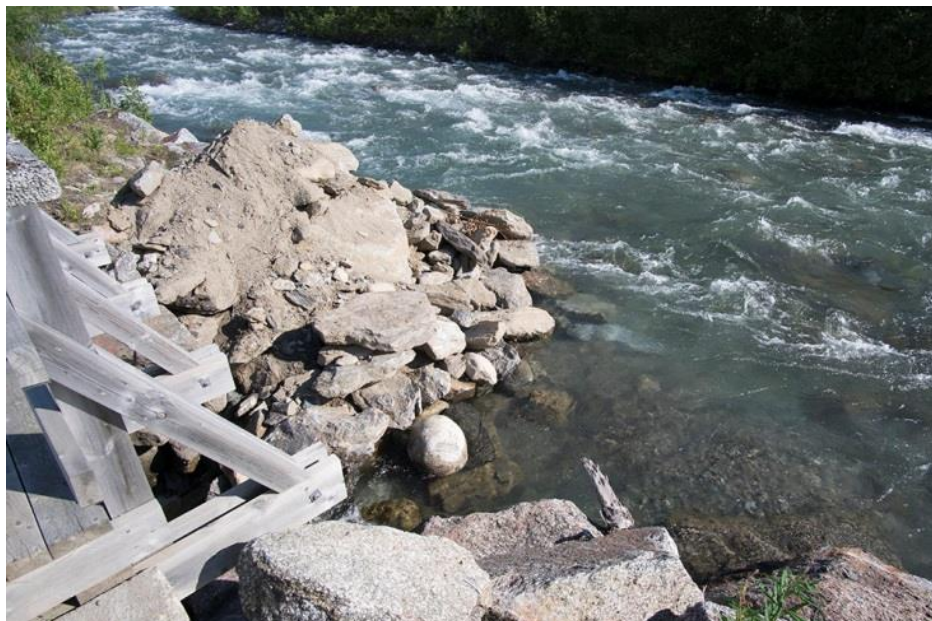
Figure 31. Boulders blocking the intake to Budalsfaret, due to fear of a destructive flood.

Regarding Budalsfaret and the Storøra meander, the high rate of silt sedimentation and periodically low flow conditions appear to be detrimental to these areas as both juvenile brown trout and benthic macroinvertebrate habitat. The bottom substrate in the tributaries Budalselva and Stordalselva appeared unstable and sterile, much like the substrate in the main river channel. Due to local farmers worrying about a destructive spring flood in 2017, much of the intake of water from Budalselva into the Budalsfaret tributary were blocked by a truckload of boulders (Granheim, T. J. 2017, The Norwegian Water Resources and Energy Directorate (NVE), pers. commun.), from June through the entire study period (Figure 31). This might have caused juvenile brown trout to disperse away from the Budalsfaret tributary and the Storøra meander due to low flow, prior to sampling being conducted.

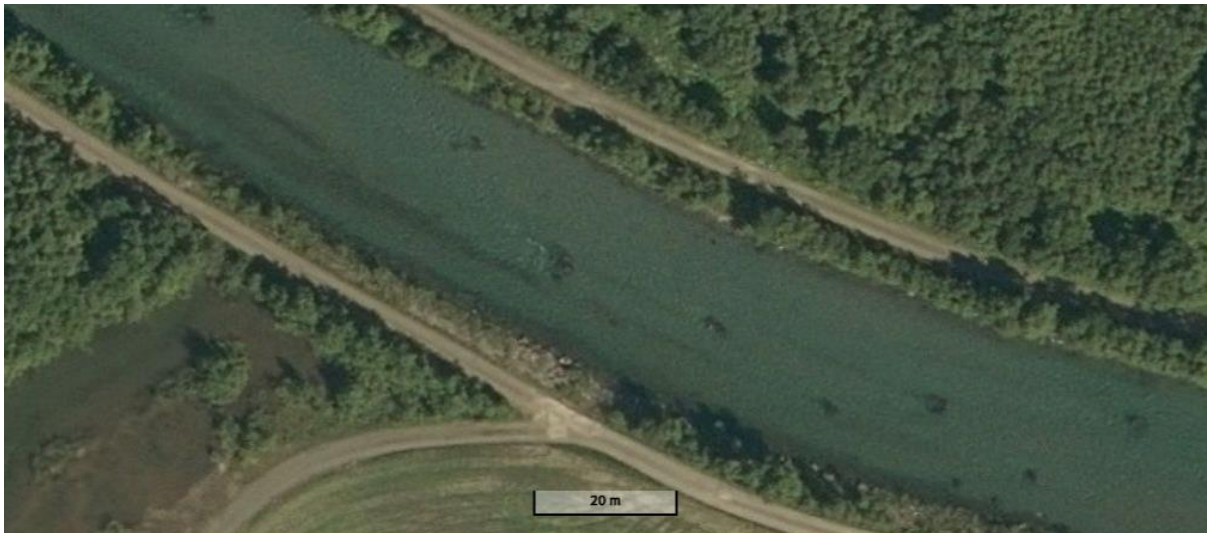
Stone groups in the main river channel at Bones, seen from above (www.norgeskart.no).

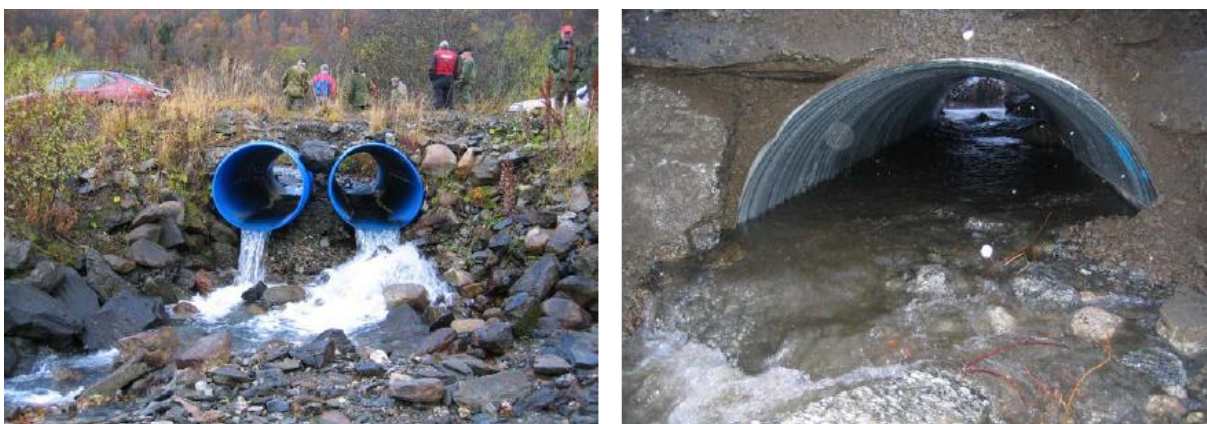
Culvert constructions at Bones; old (left) and new (right). New culvert construction facilitating the movement of organisms between the main river channel and its tributary (Hoseth 2017).
