Norwegian University  
of Life Sciences

**Master's Thesis 2020 60 ECTS**

# **Water quality affected by interactions with filter media in raingardens**

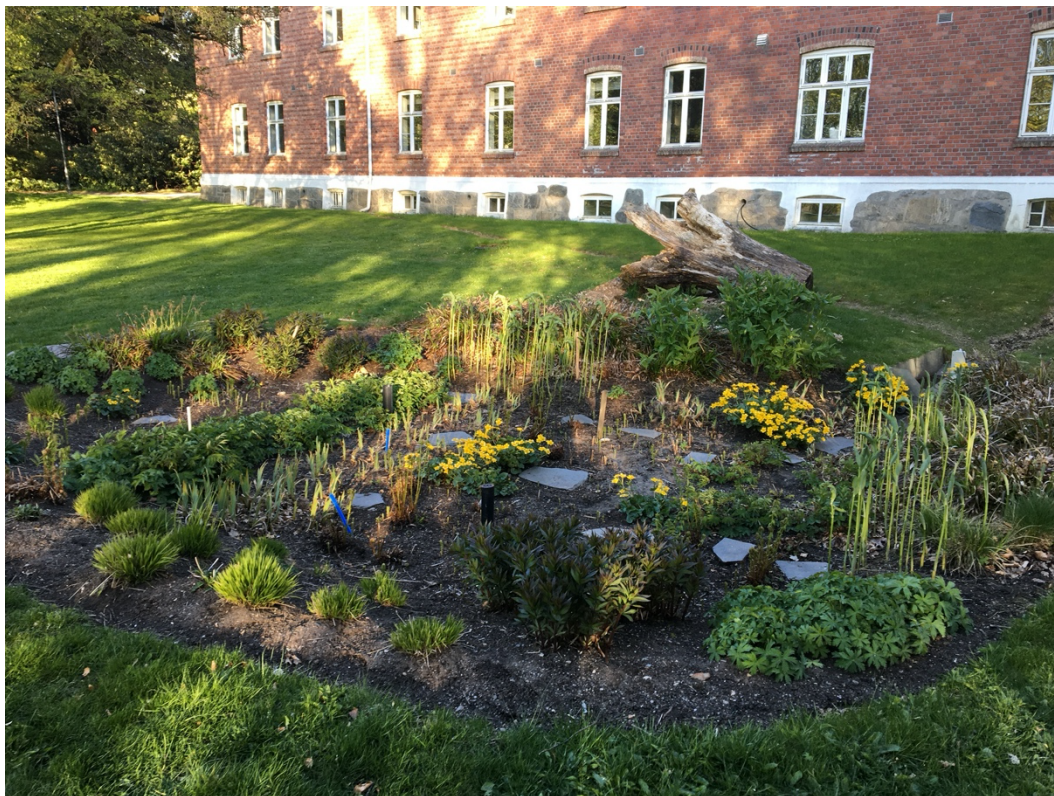
Figure 1.3 The NMBU research raingarden with the building Tivoli in the background, spring 2020.

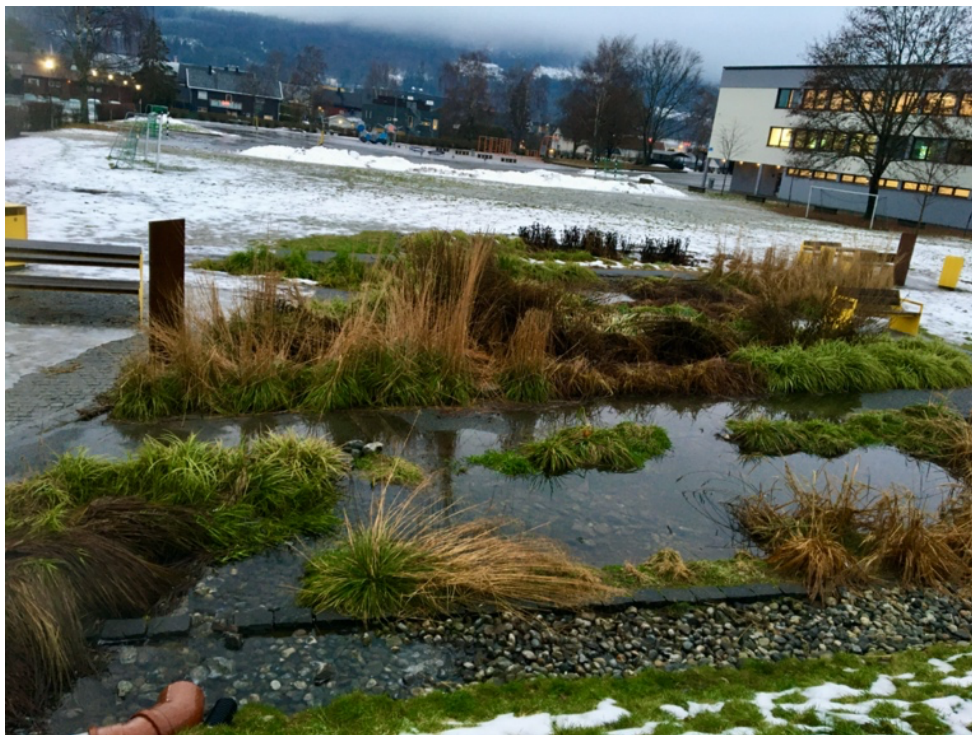
*Figure 1.5 Bolstadhagen raingarden 13. December 2019. Raingarden 1 is in the front and raingarden four is furthest away. Kjøsterud ungdomsskole can be seen in the background.*

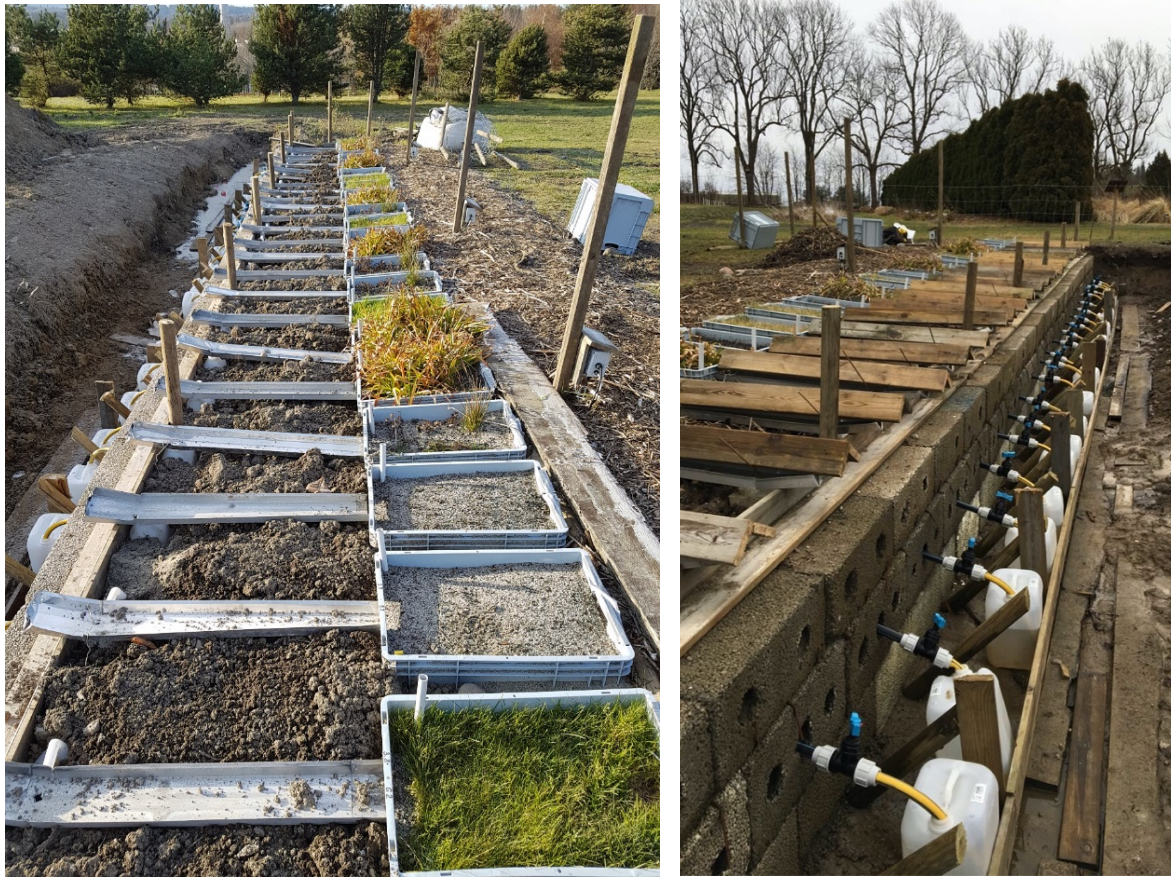
Figure 1.10 Mesocosm set up at Planteskolen, NMBU. Right picture show top of plant boxes and surface runoff system left picture shows system for collection of drained water. (right pic. Marina Bakhtina 5. Nov 19)

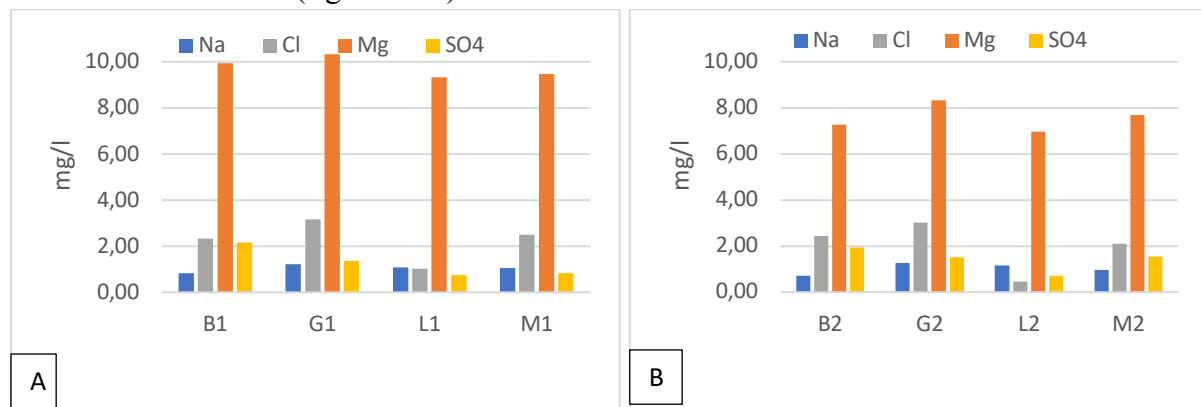
Figure 3.32. Sodium, Chloride, Magnesium and Sulphate in the drained water from the mesocosm experiment. A soil type 1 and B soil type 2.
