Norwegian University
of Life Sciences

Master's Thesis 2022 60 ECTS

Evaluating the efficacy of alpine restoration actions at Elgsjøveien, Norway

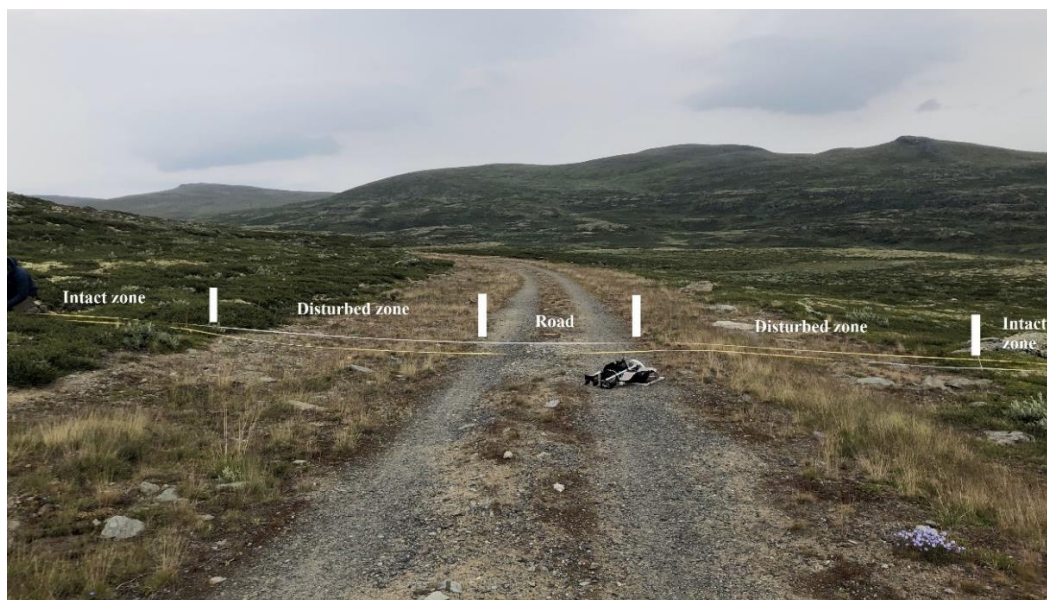
Figure 1: The transects are positioned across the road, and into vegetation (disturbed zone and intact zone, respectively) on both sides of the road.

In 2016, 15 transects were established to monitor vegetation along the road (Fig.1) (Hagen et al., 2017; Hagen et al., 2019). The 15 transects were positioned in three vegetation types including ridge (six transects), willow (six transects) and wetland (three transects) (Fig.2). Maximum and minimum distance between the transects is 30 meters and 10 meters, respectively. Each transect was positioned perpendicular to Elgsjøveien and into vegetation on both sides of the road (Fig. 1). Thus, all transects consist of road in the middle, disturbed zones on both sides of the road where restoration was carried out, and intact zones at the beginning and end of the transect. The length of the transects was 17 meters.

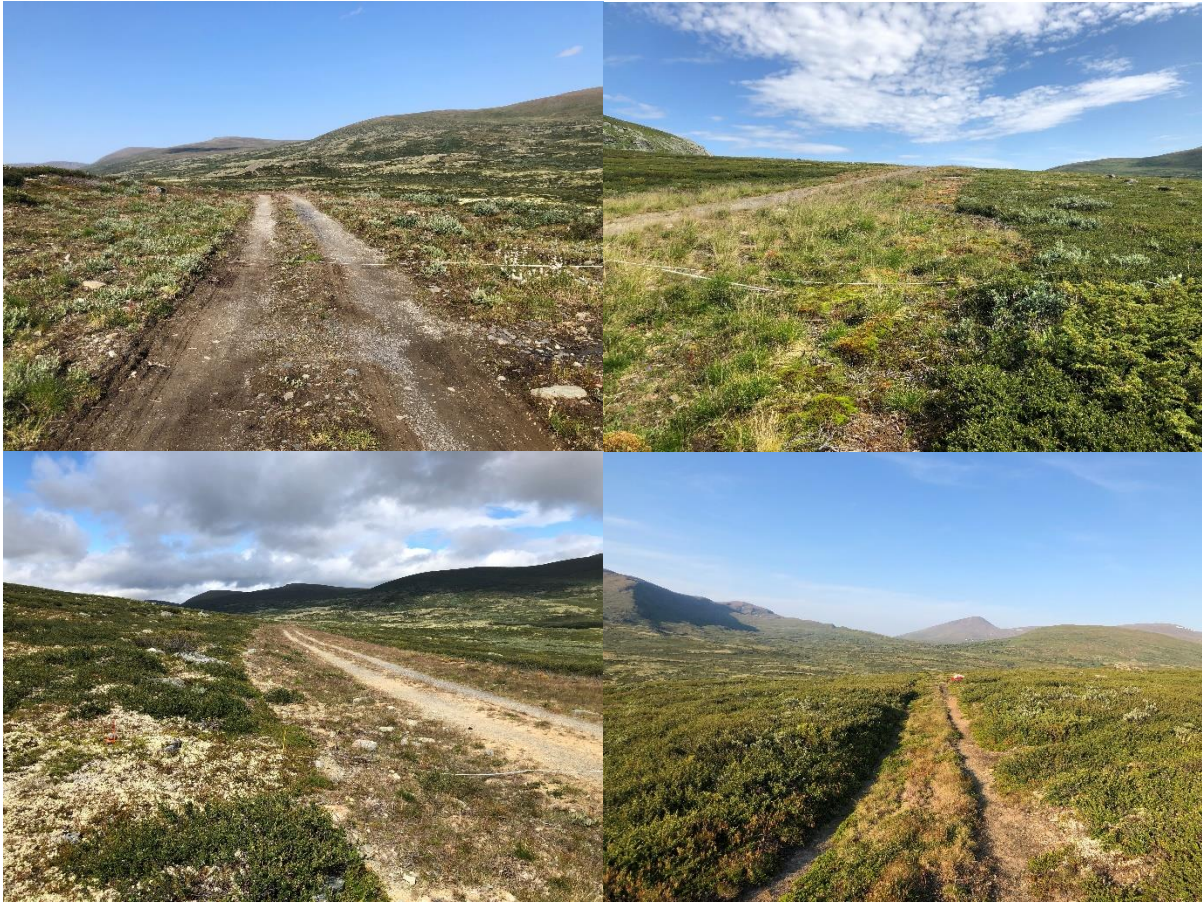
Figure 4: *Transects of different vegetation types from year 2021. Wetland (transect 5) topleft, willow heath (transect 15) topright, ridge (transect 7) bottom left, and willow bottom right (reference site 1).*

A nearby, old, simple “two-track” road was used as a reference site in 2021 (Fig.2; Fig.4). Even though it differs in road quality to Elgsjøveien, it is useful for comparison because it is located near Elgsjøveien and represents a later successional stage that the disturbed plots are directed towards. Five transects were established within willow (two transects) and ridge (three transects) vegetation types. All reference transects are made up of road and intact zone with a total length of 1700 cm and are permanently marked with GPS locations. Environmental variables were not recorded for reference sites.
