Norwegian University  
of Life Sciences

**Master's Thesis 2023 30 ECTS**

# **Riverscape Restoration: Tromsa River in Norway, after Dam Removal**

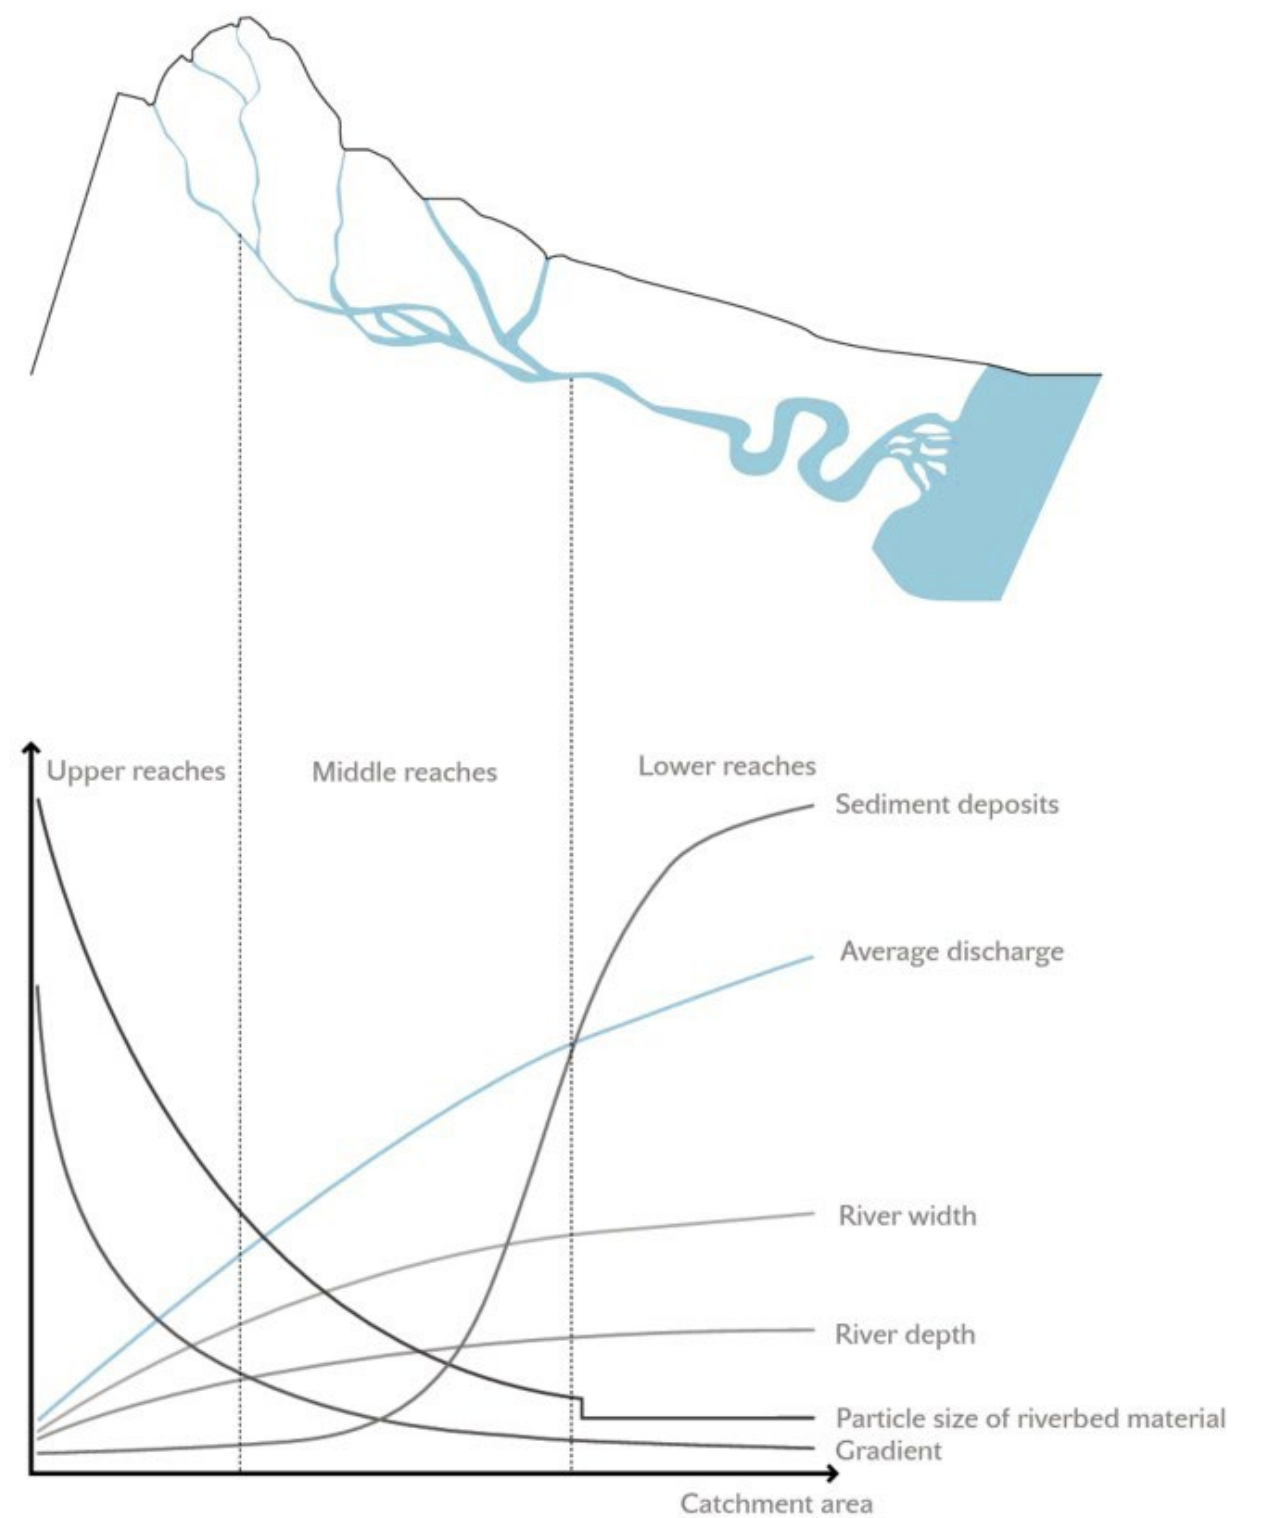
Figure 7: Description of how the transportation of sediments and how a river changes its from (Image source: Prominski et al., 2017 (p. 27)).

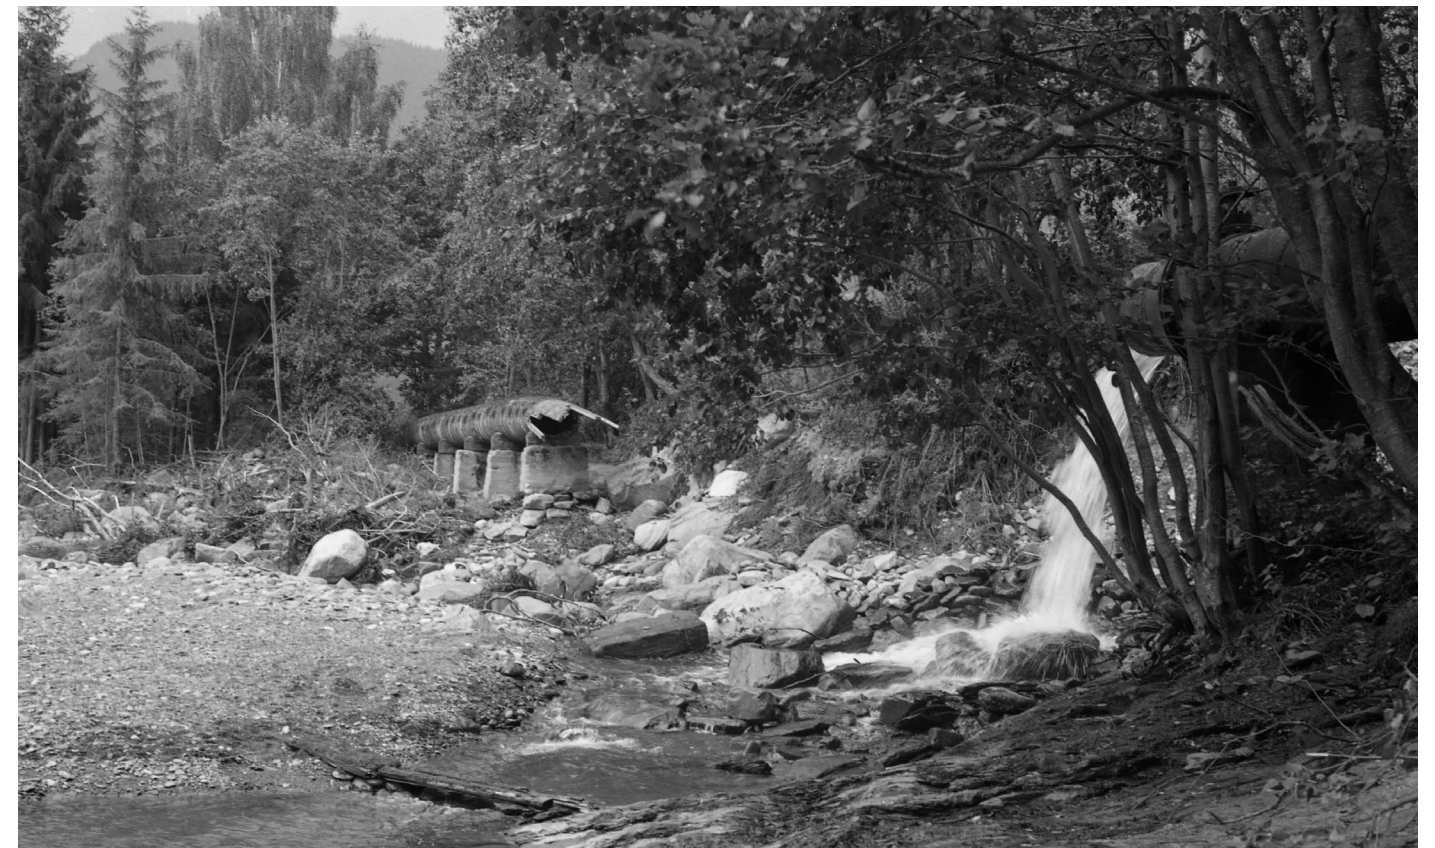
Figure 9b: A spring flood broke the pipes of the dam at Tromsa river, in 1985 (Photo: Sparby, K., 1985).

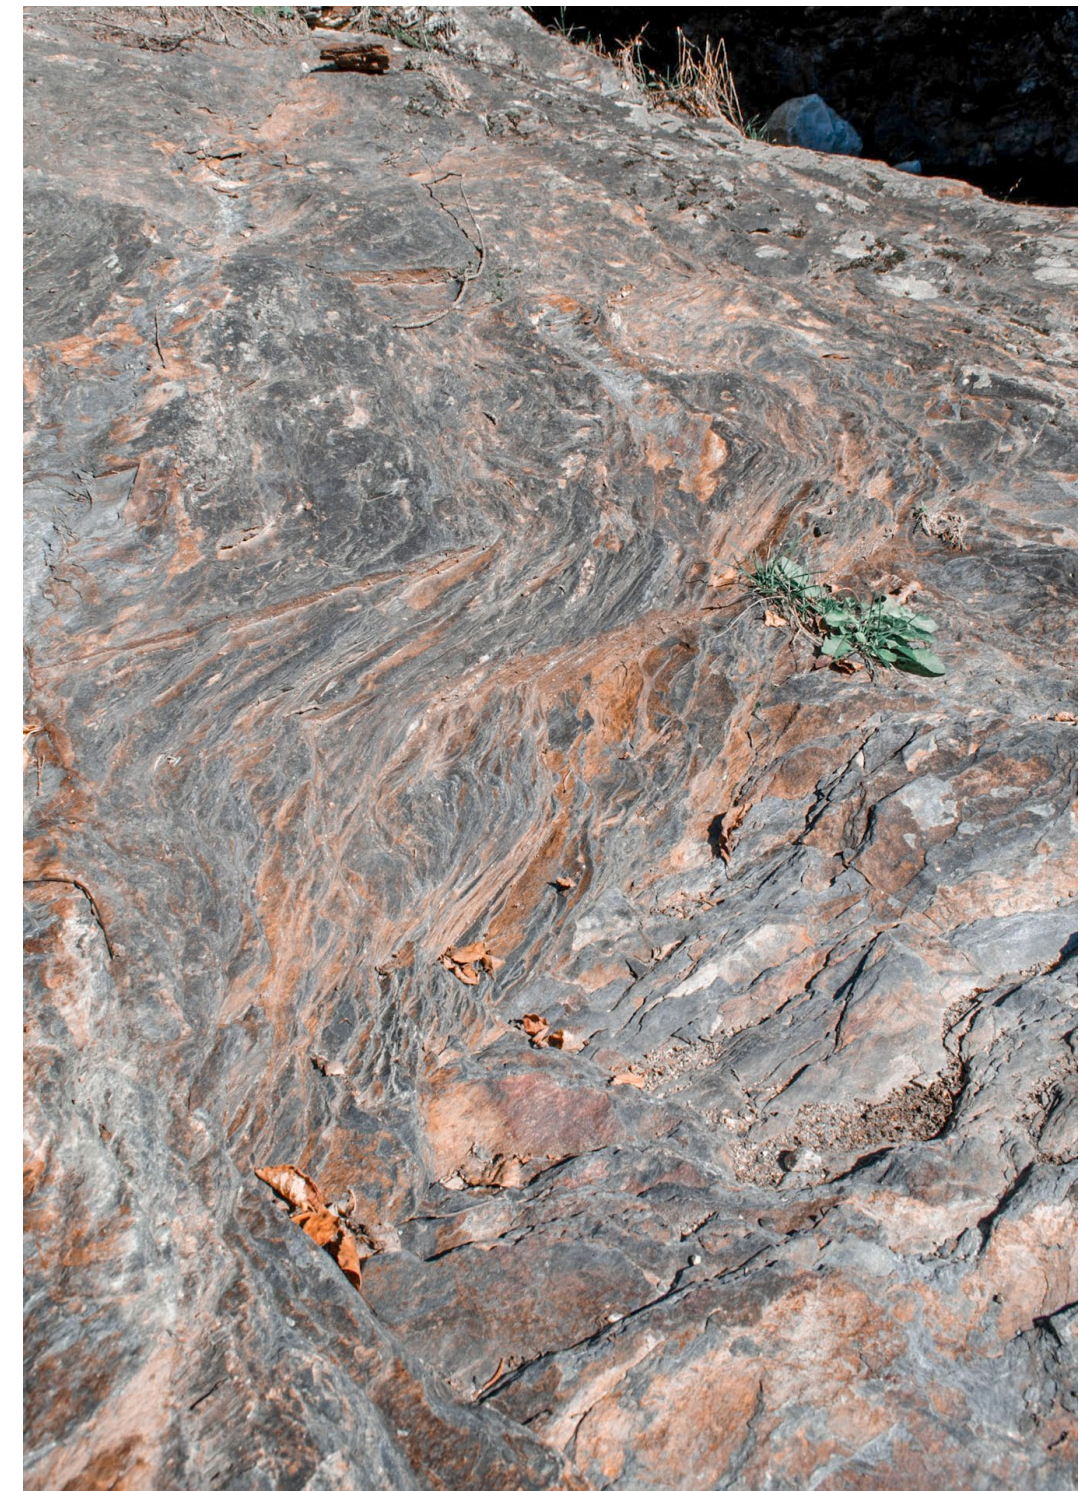
Figure 24b: Geology at the dam site (Photo: Fjeldberg, I. 2022).

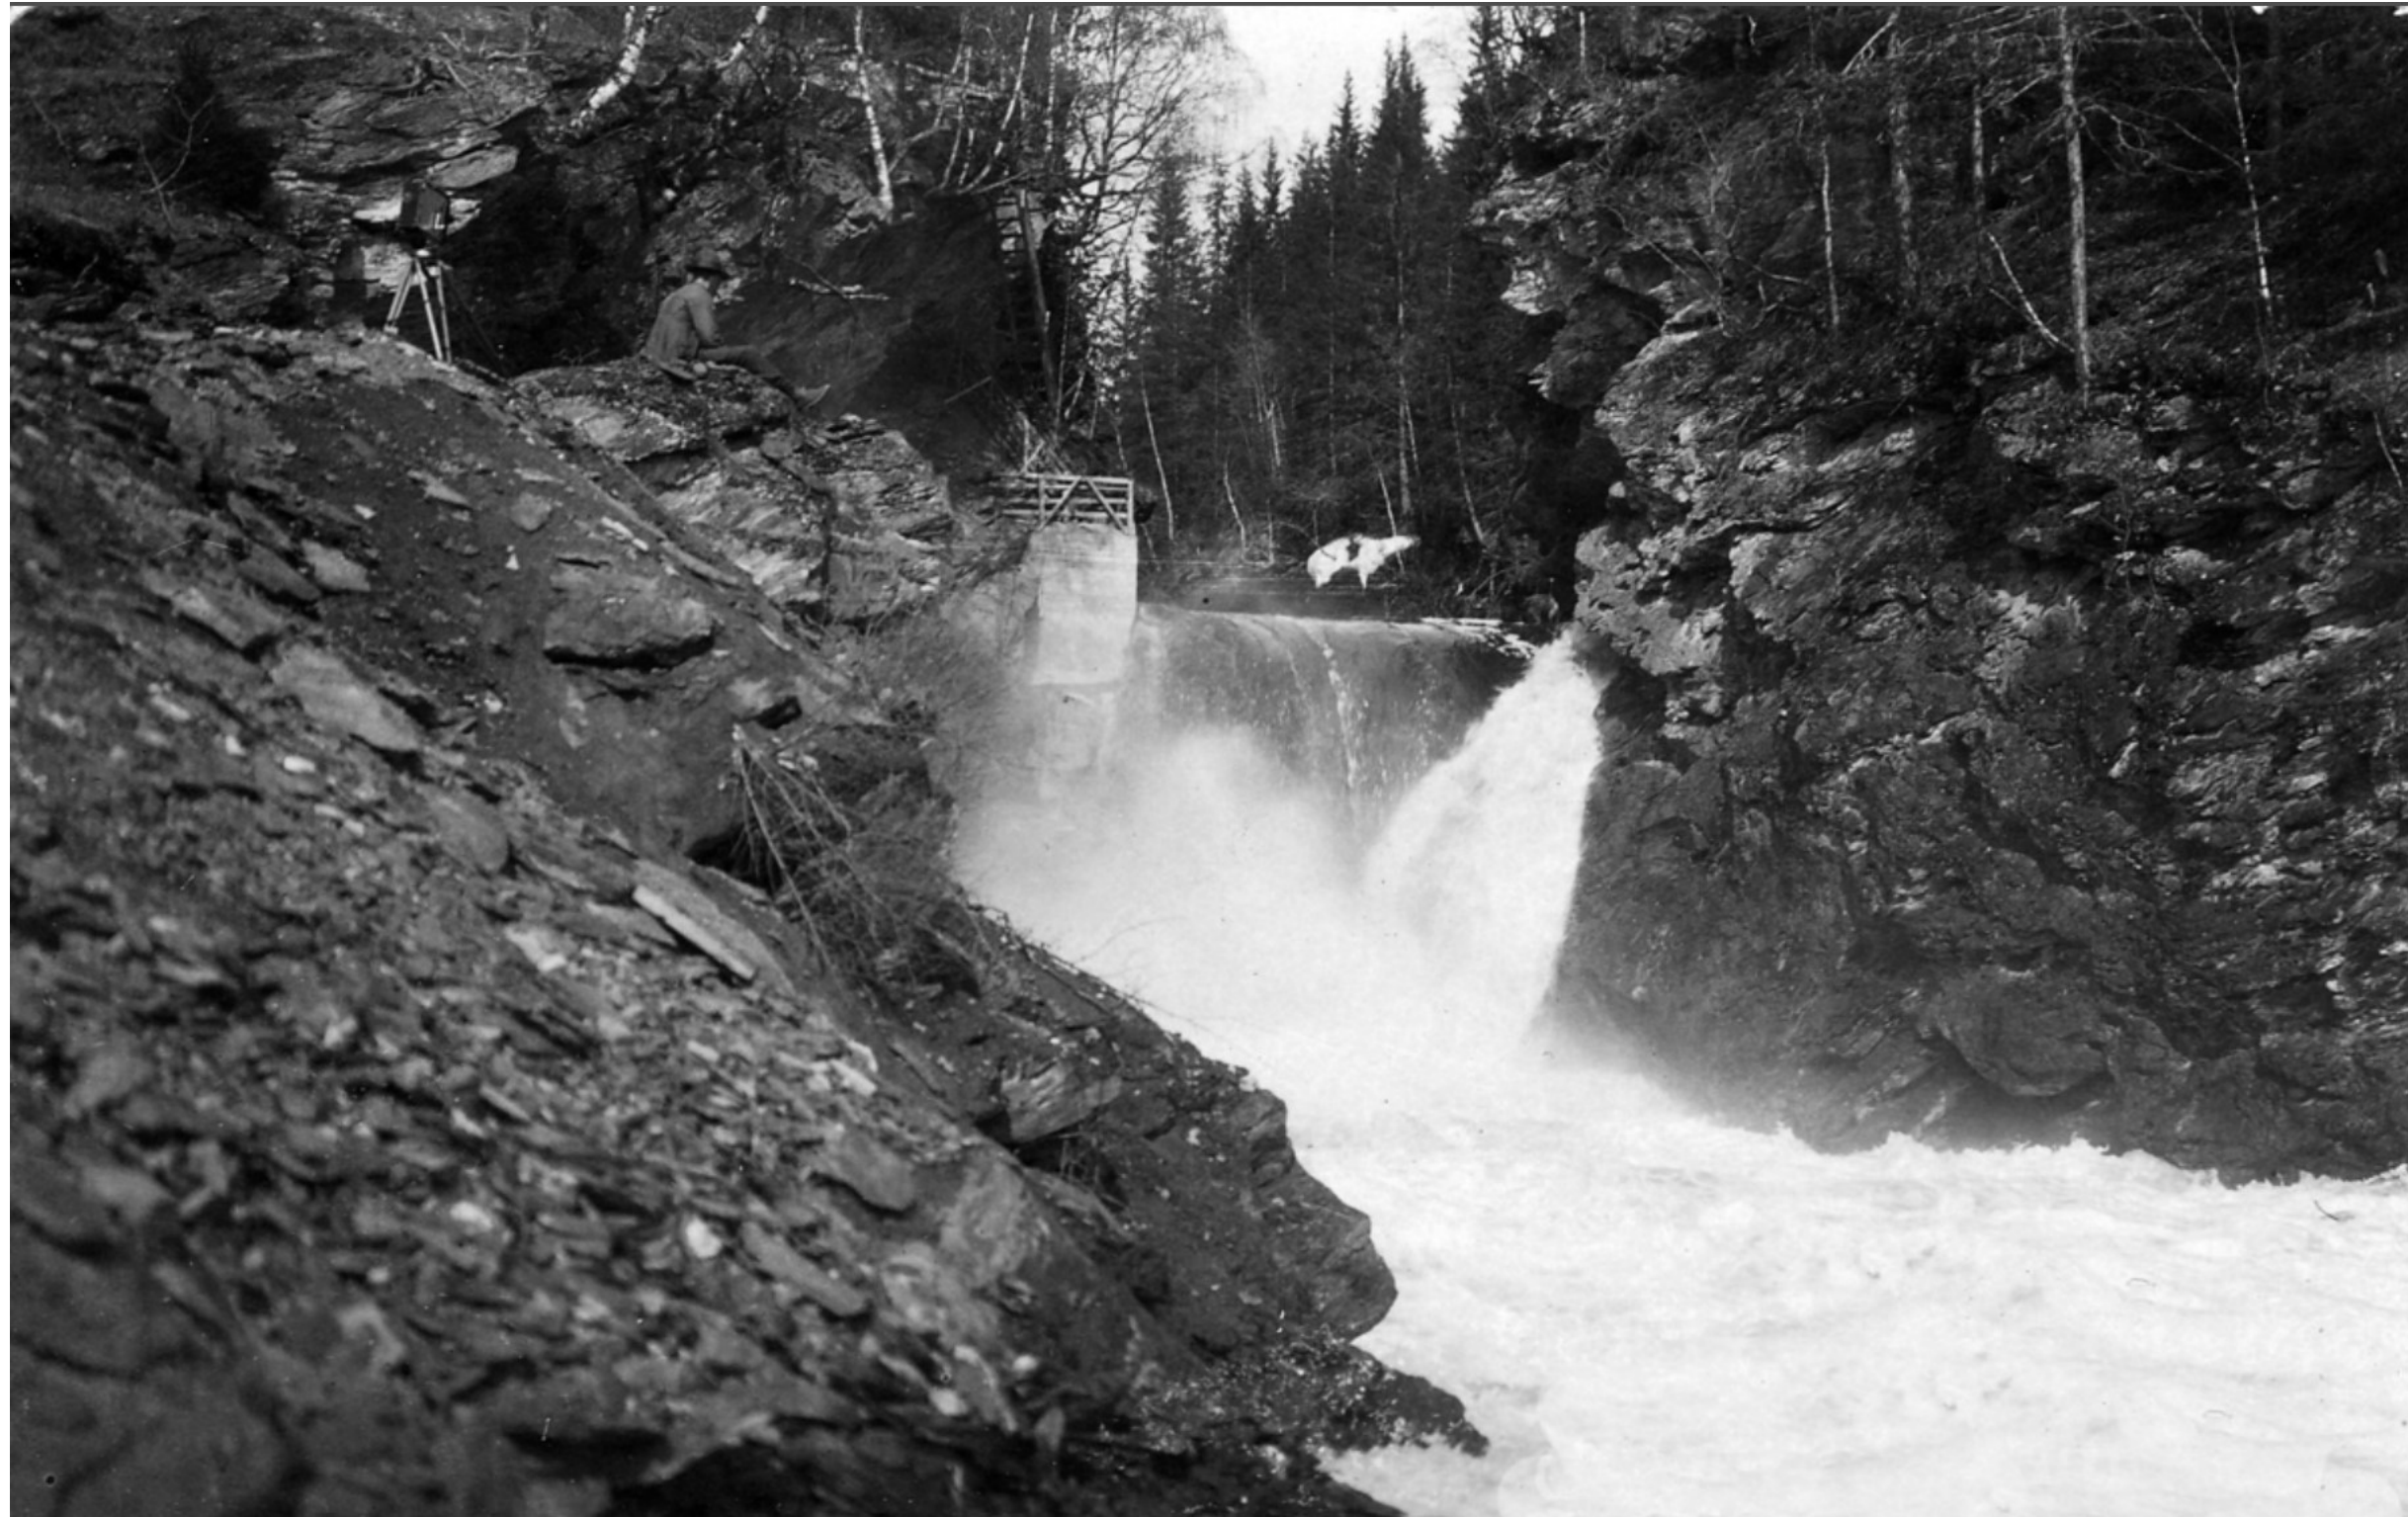
Figure 39: Tromsa dam in 1917 (Photo: 1917, borrowed from Ringebu Historielag).

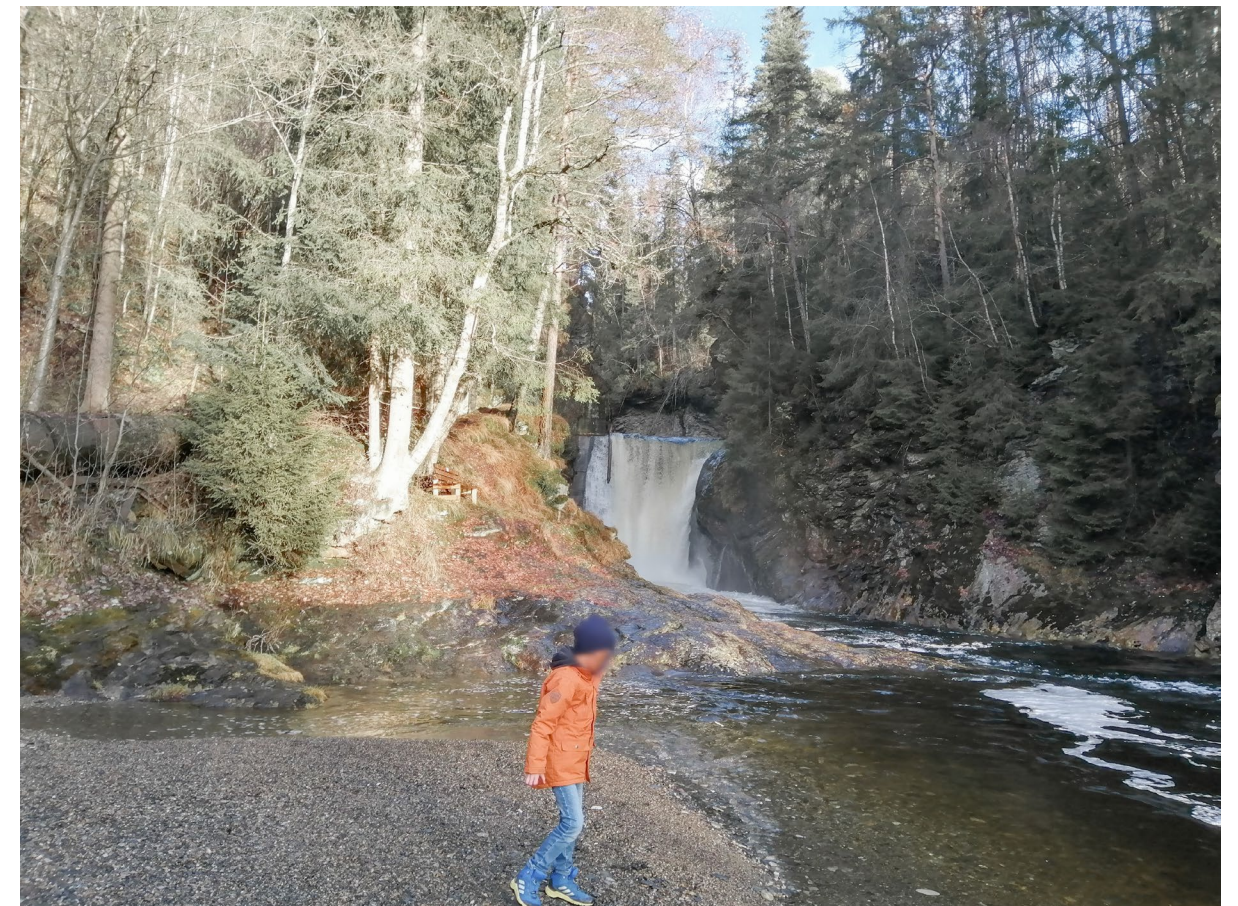
Figure 45b: The site at the dam before removal. The photo was taken before the latest replacement of the High bridge (Photo: Ringlund, O. 2020).

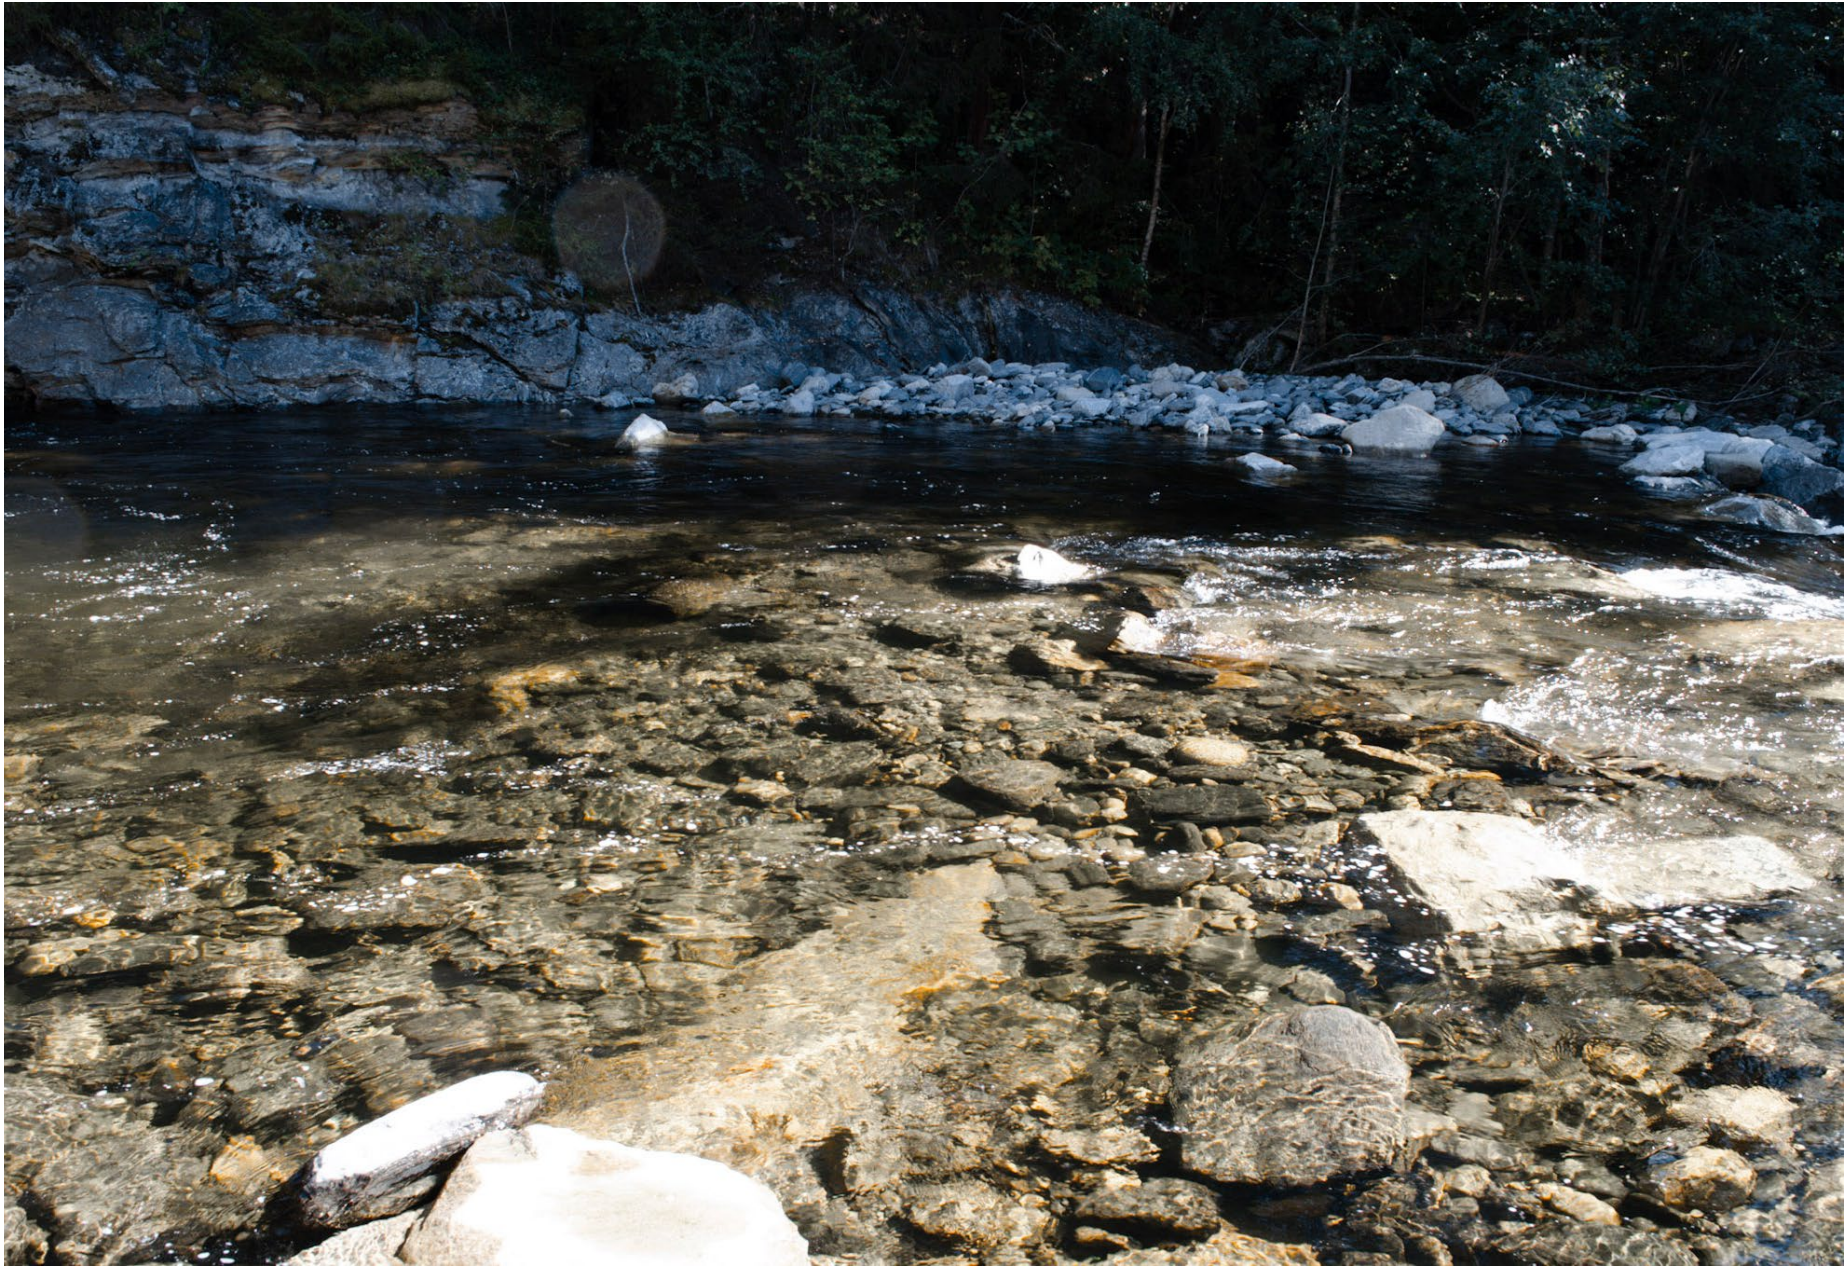
Figure 56b: One of the habitat pools at the dam site (Photo: Fjeldberg, I. 2022).

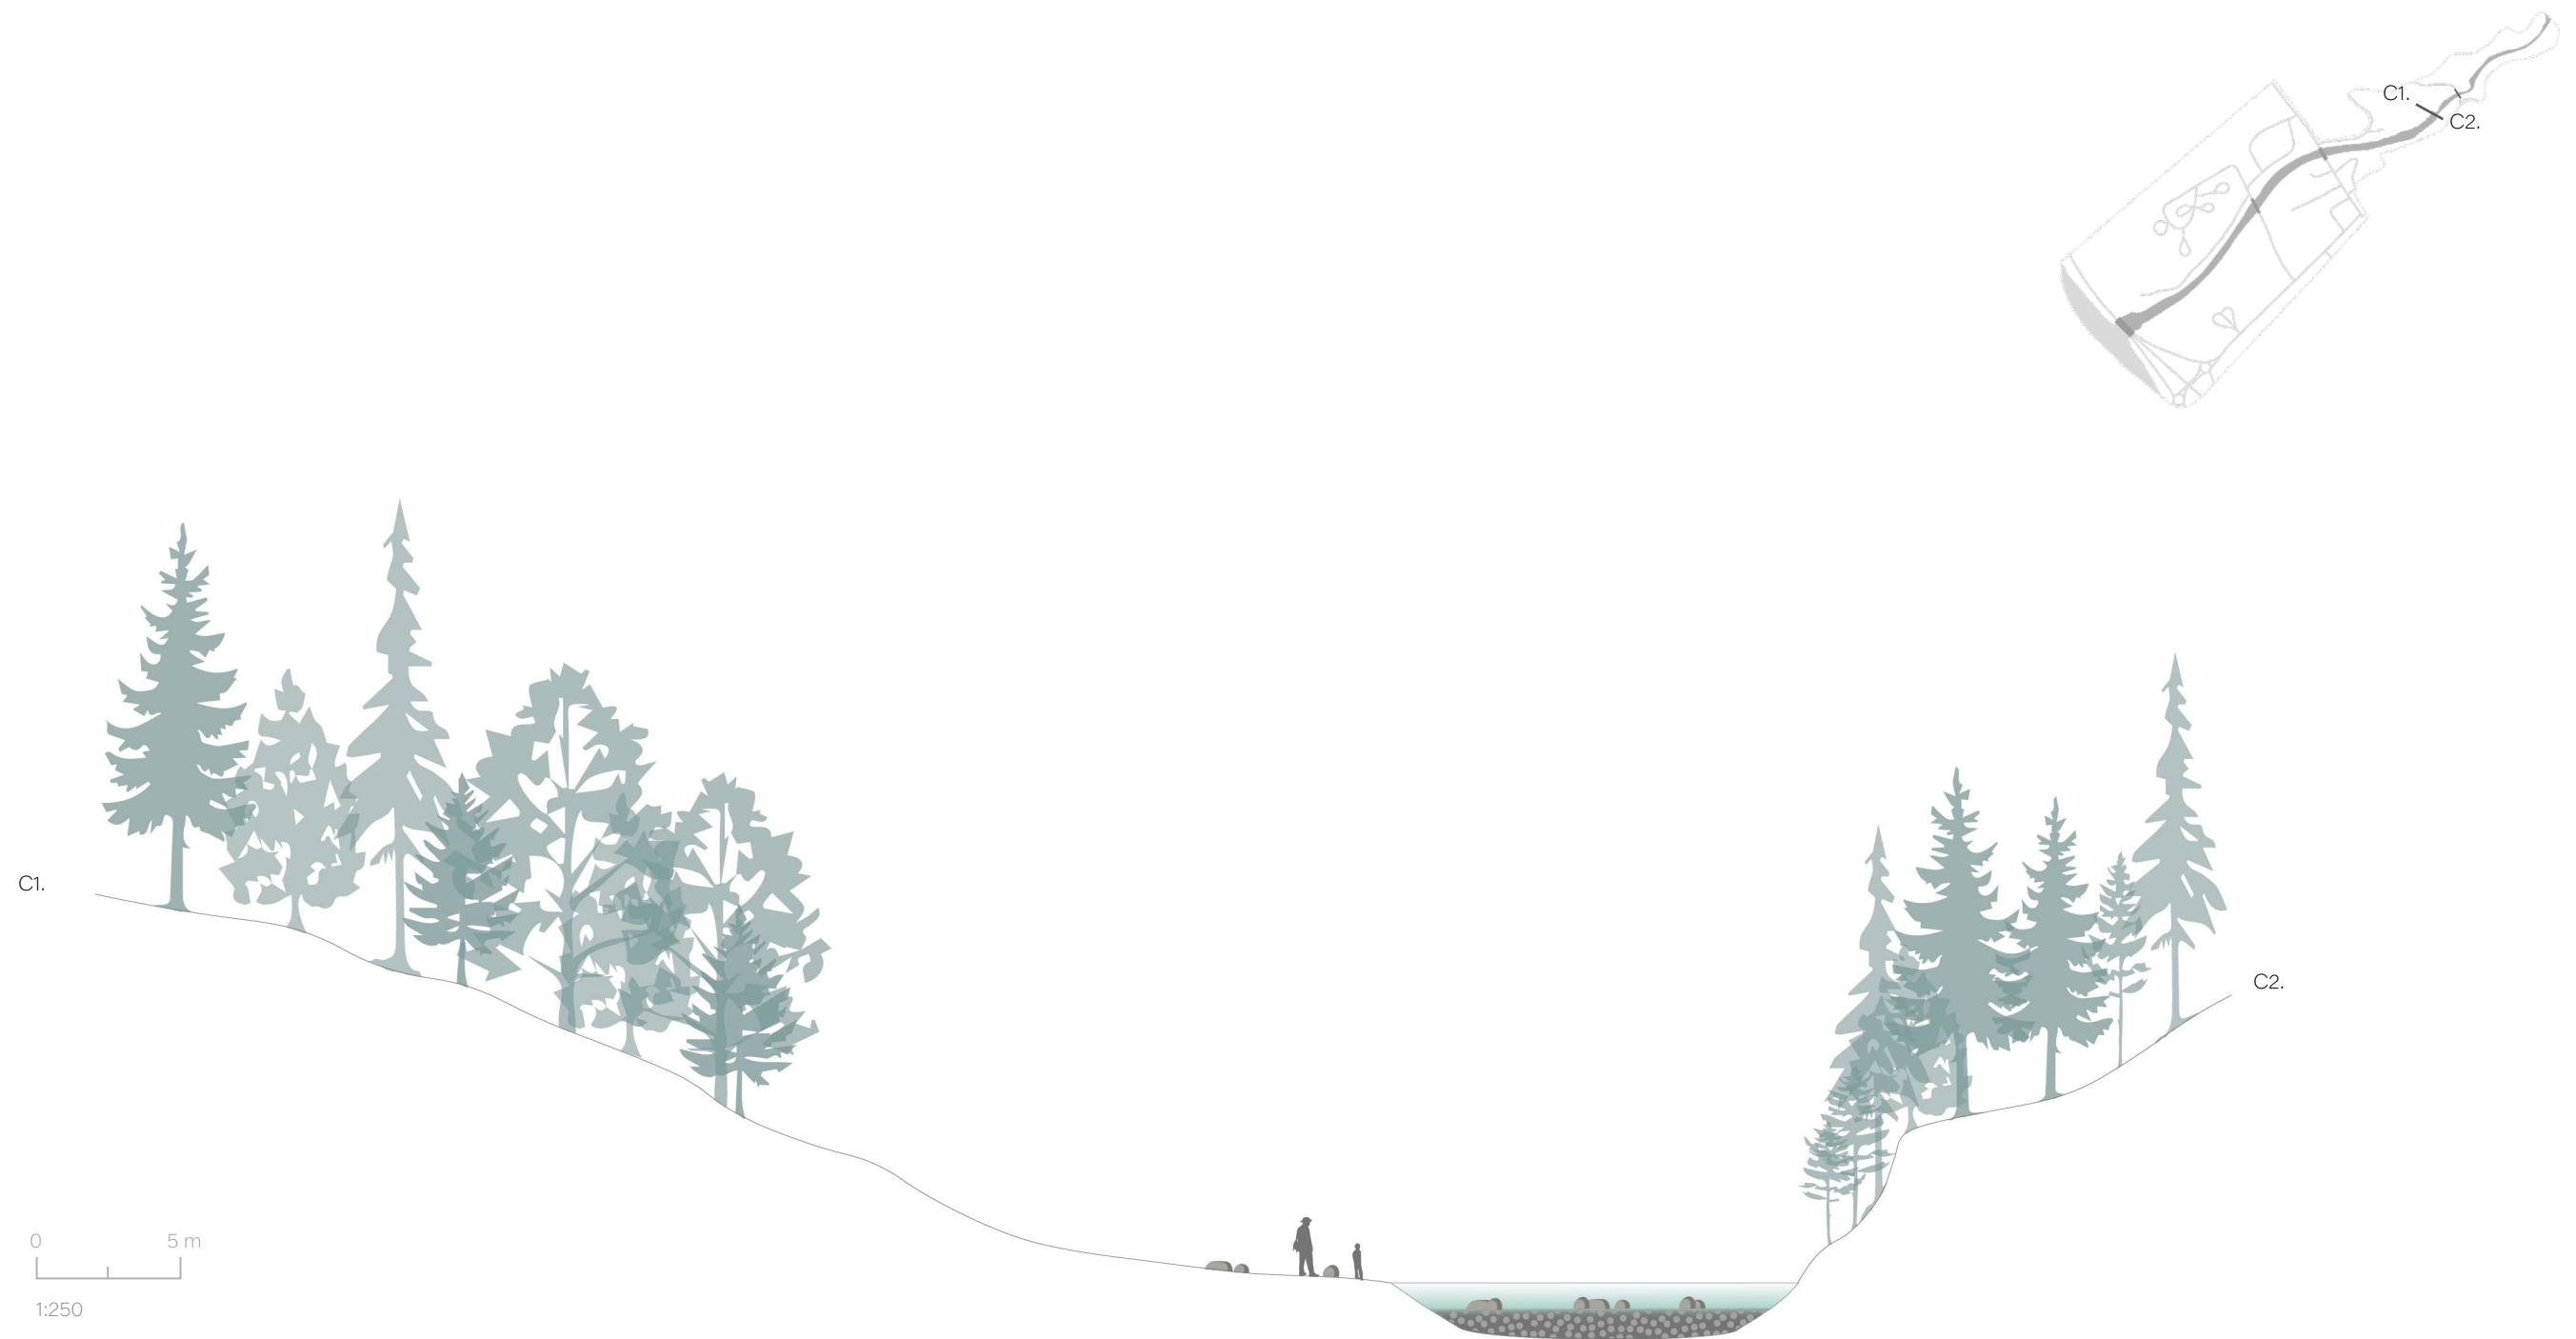
Figure 59d: Section C1-C2 (illustration: Fjeldberg, I. 2022).

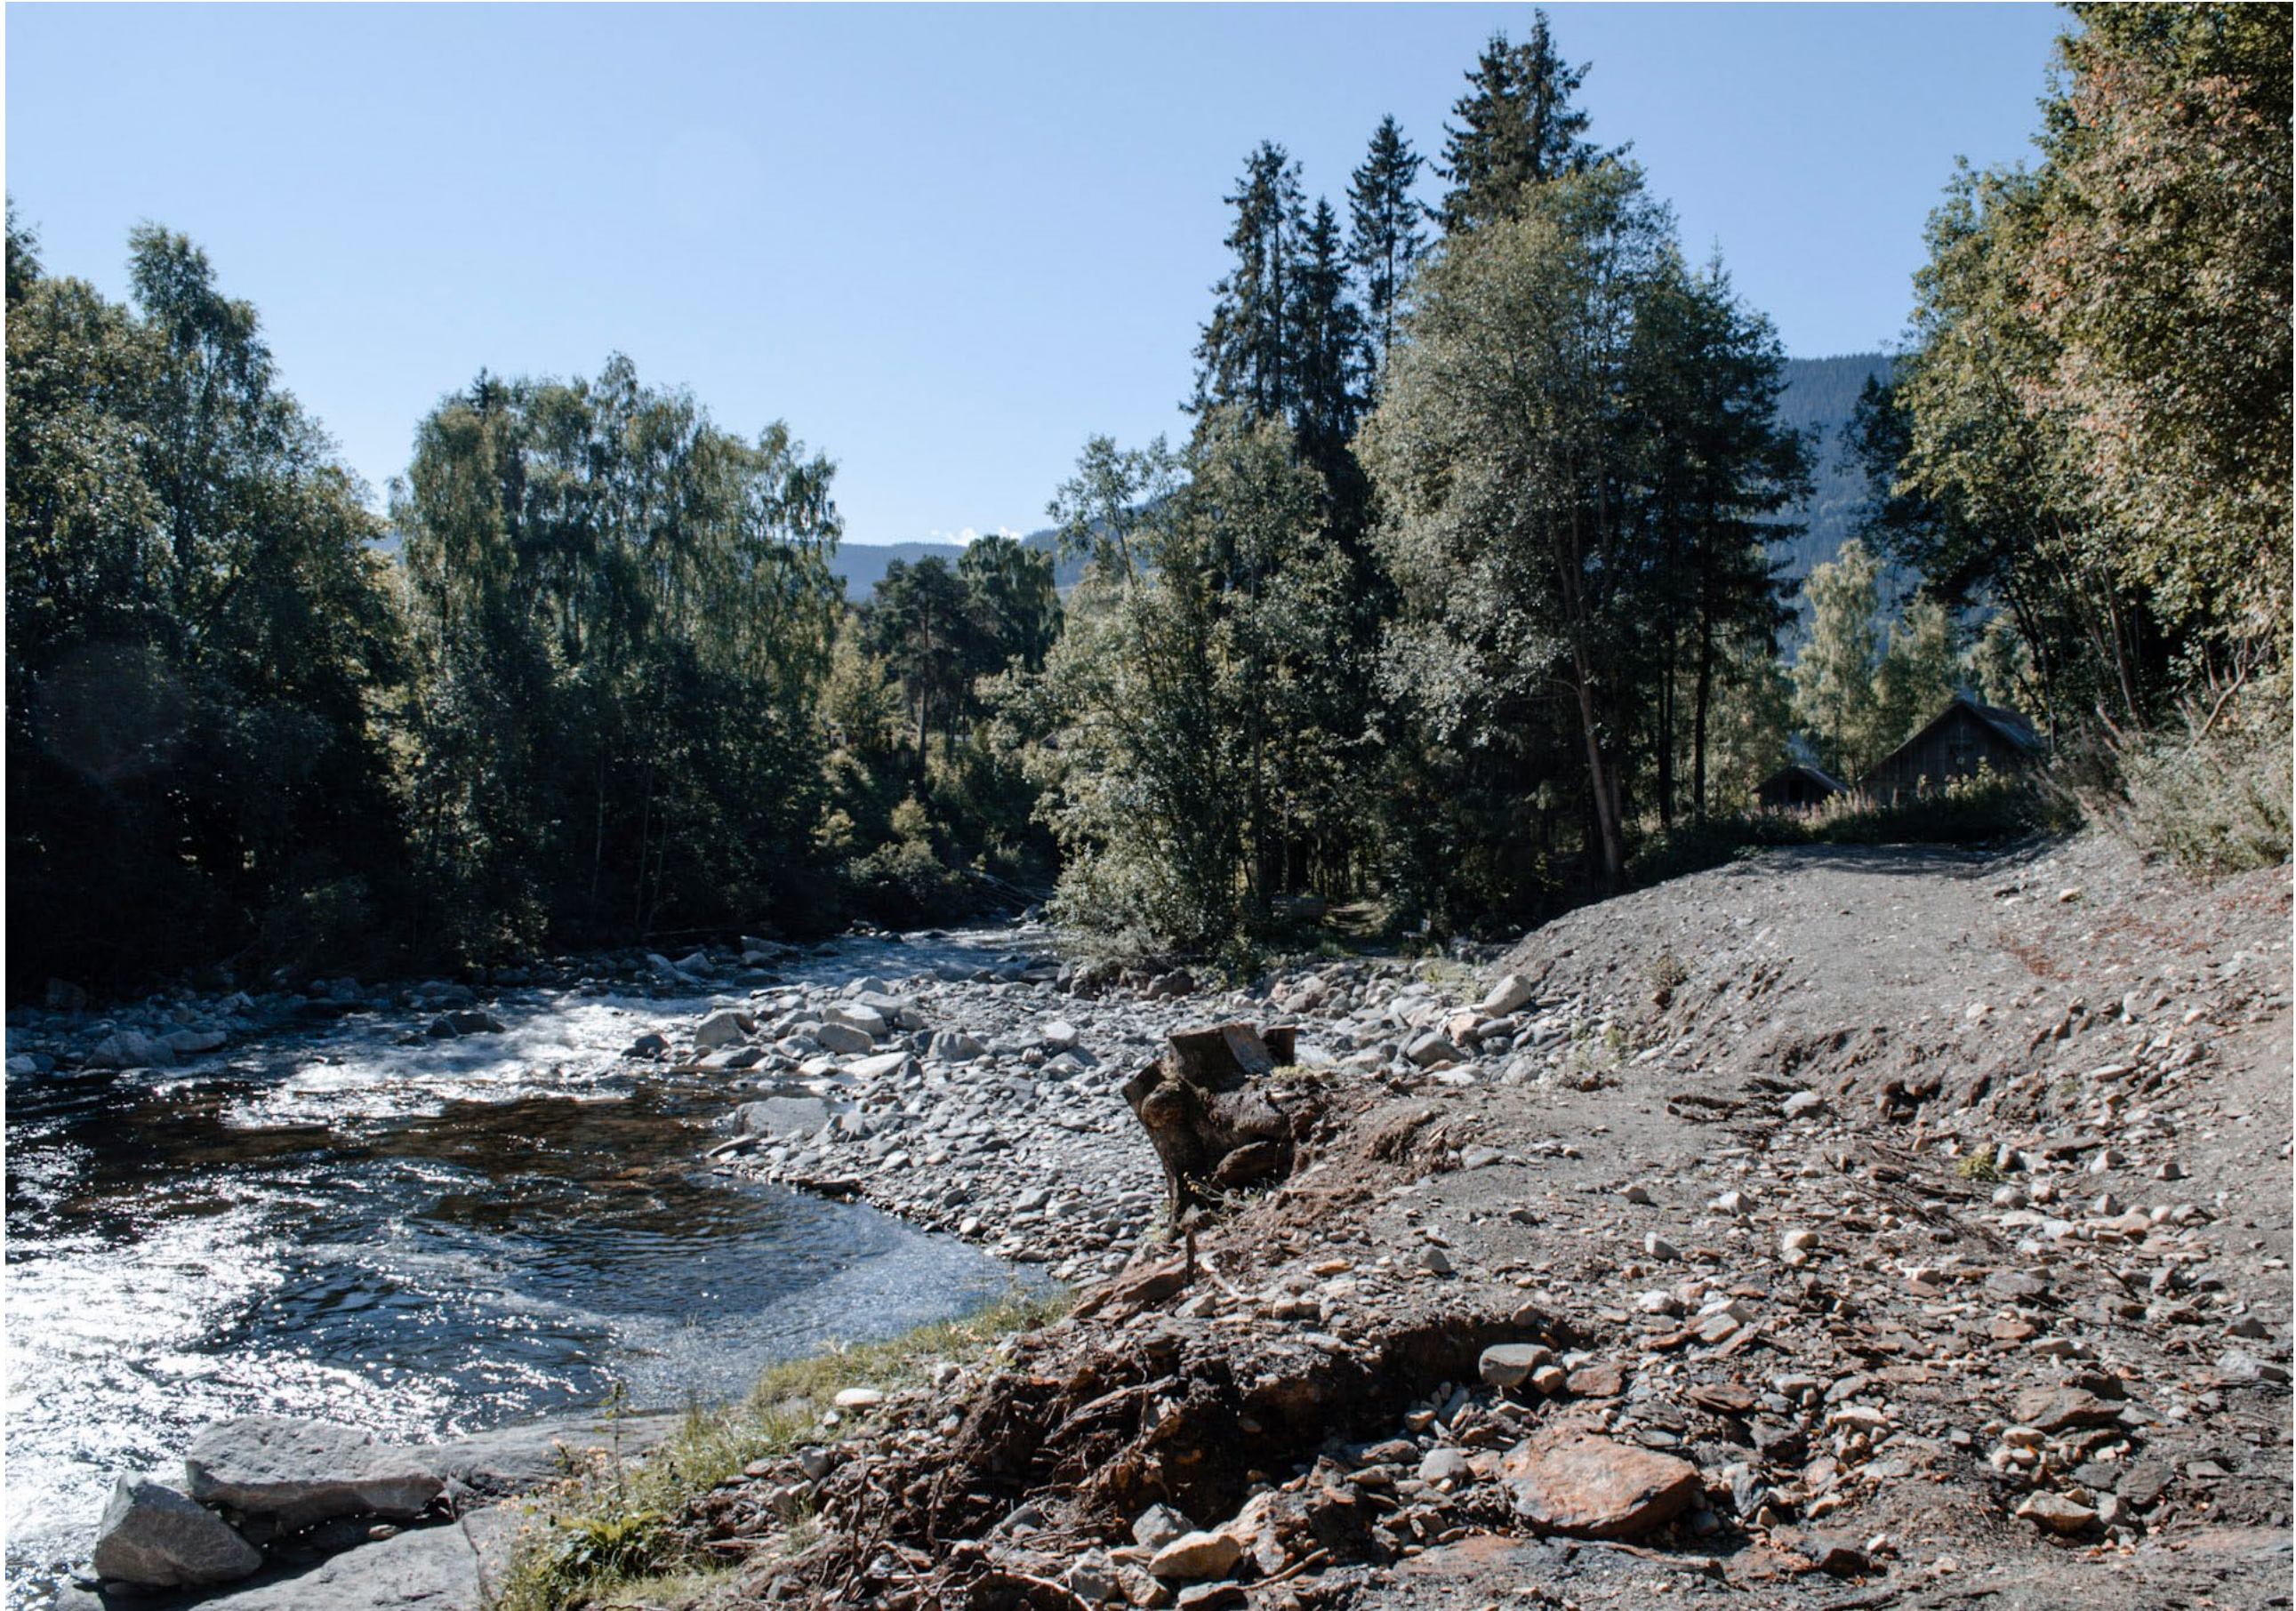
Figure 59e: View of Tromsa, with the temporarily constructed road that was washed away by the spring flood on the right (Photo: Fjeldberg, I. 2022).

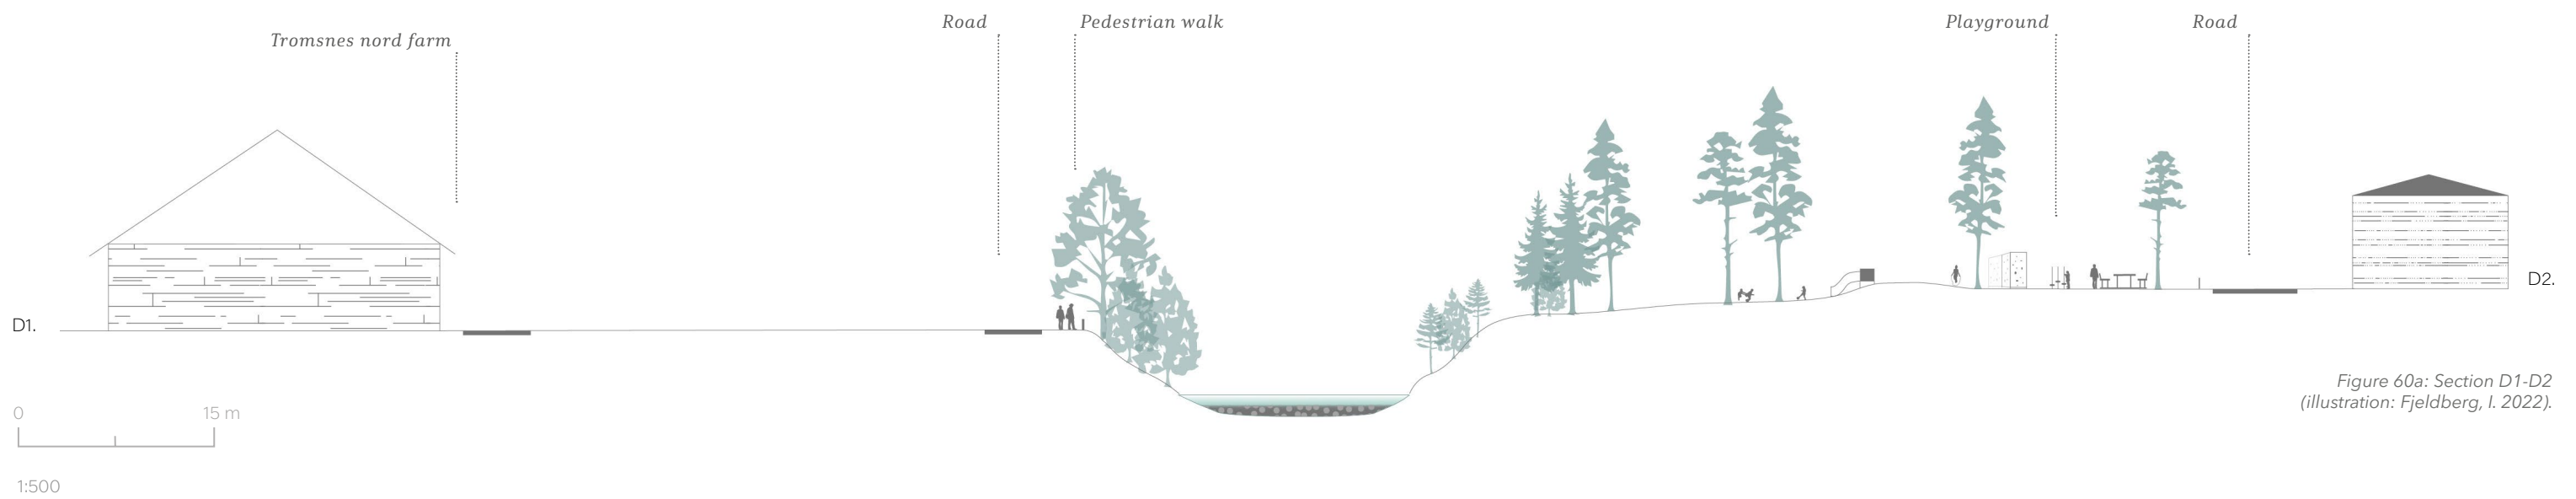
Figure 60a: Section D1-D2  
(illustration: Fjeldberg, I. 2022).

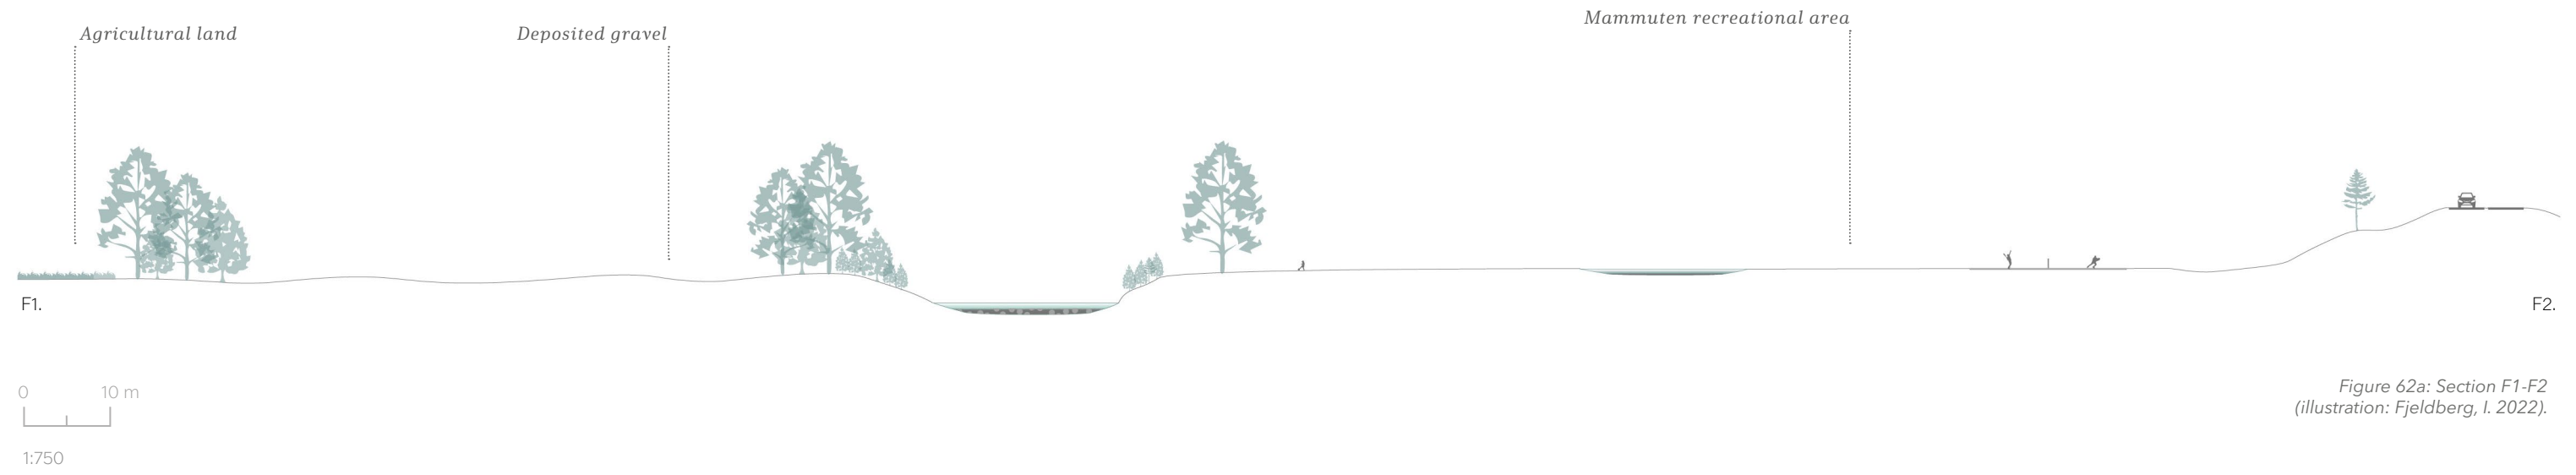
Figure 62a: Section F1-F2 (illustration: Fjeldberg, I. 2022).
