Norwegian University  
of Life Sciences

**Master's Thesis 2023 30 ECTS**

# **Riverscape Restoration: Tromsa River in Norway, after Dam Removal**

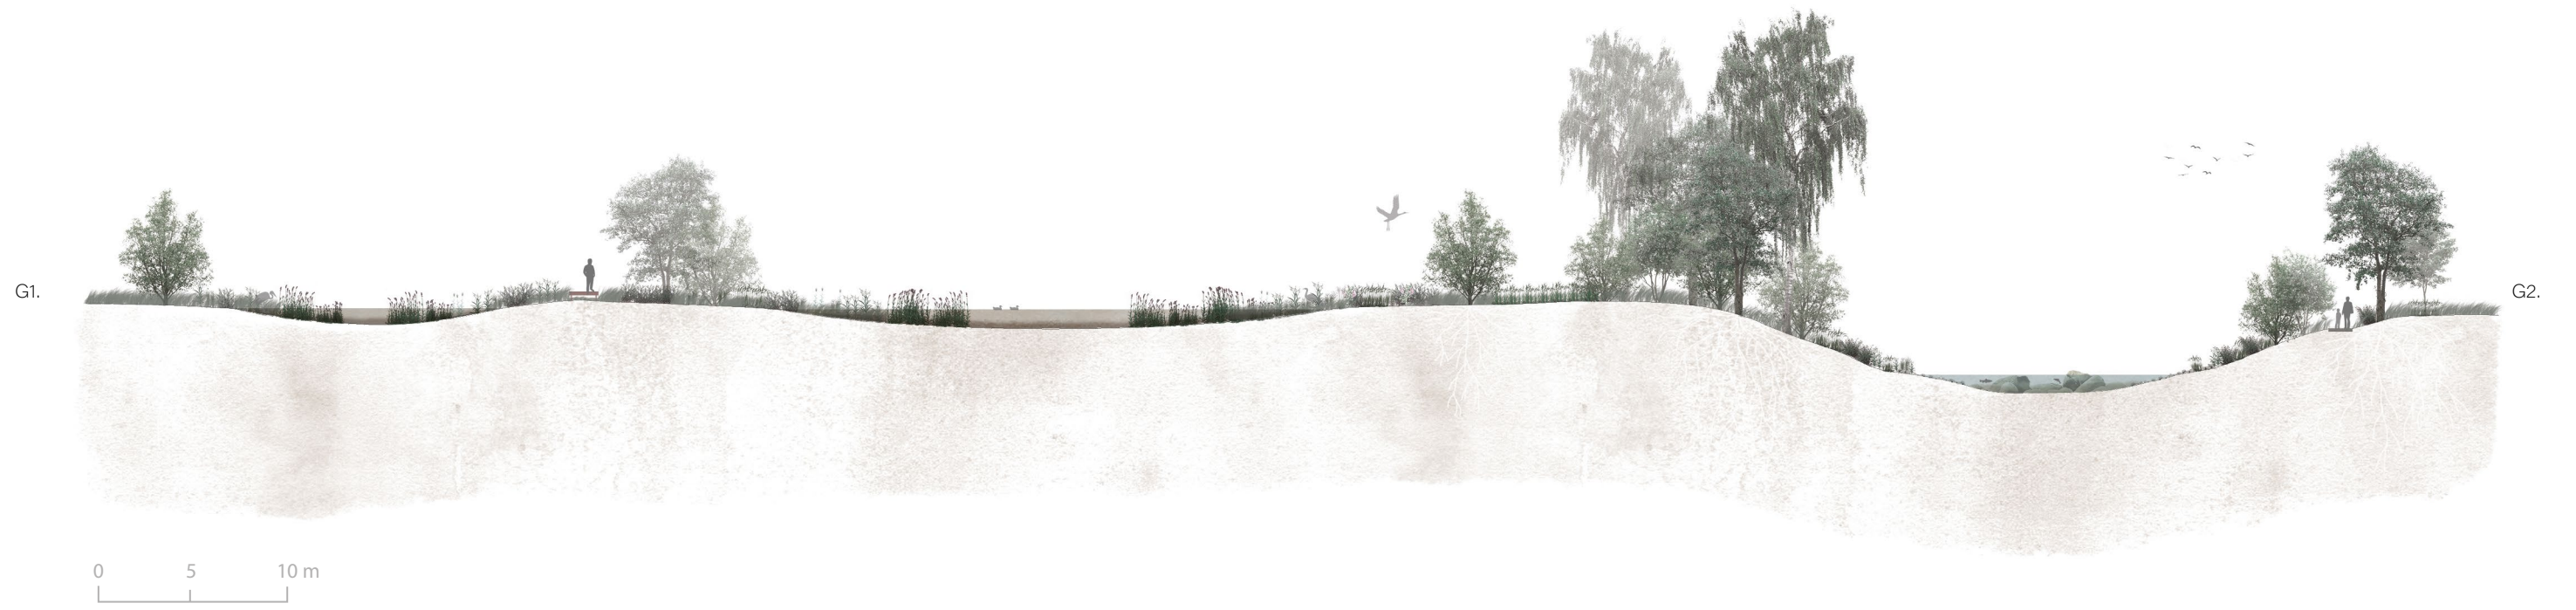
Figure 65b: Section G1.-G2. Location is shown in the proposal map, figure 65a. (Illustration: Fjeldberg, I. 2022).

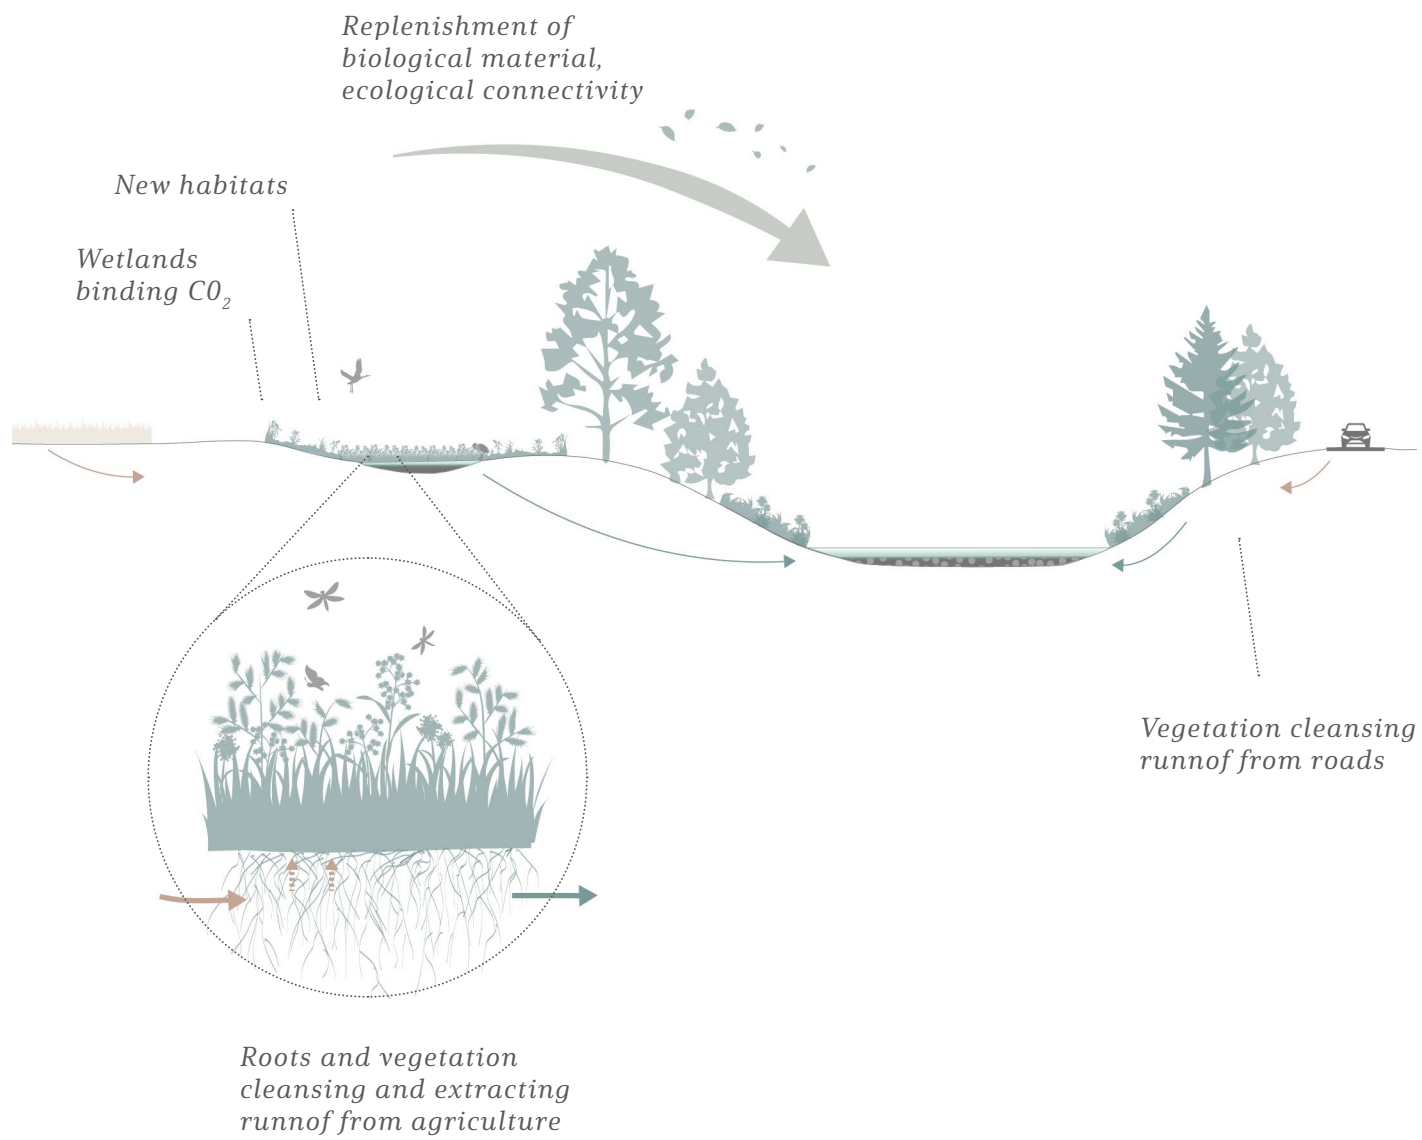
Figure 69a: Processes as a result of the proposal (Illustration: Fjeldberg, I. 2022).

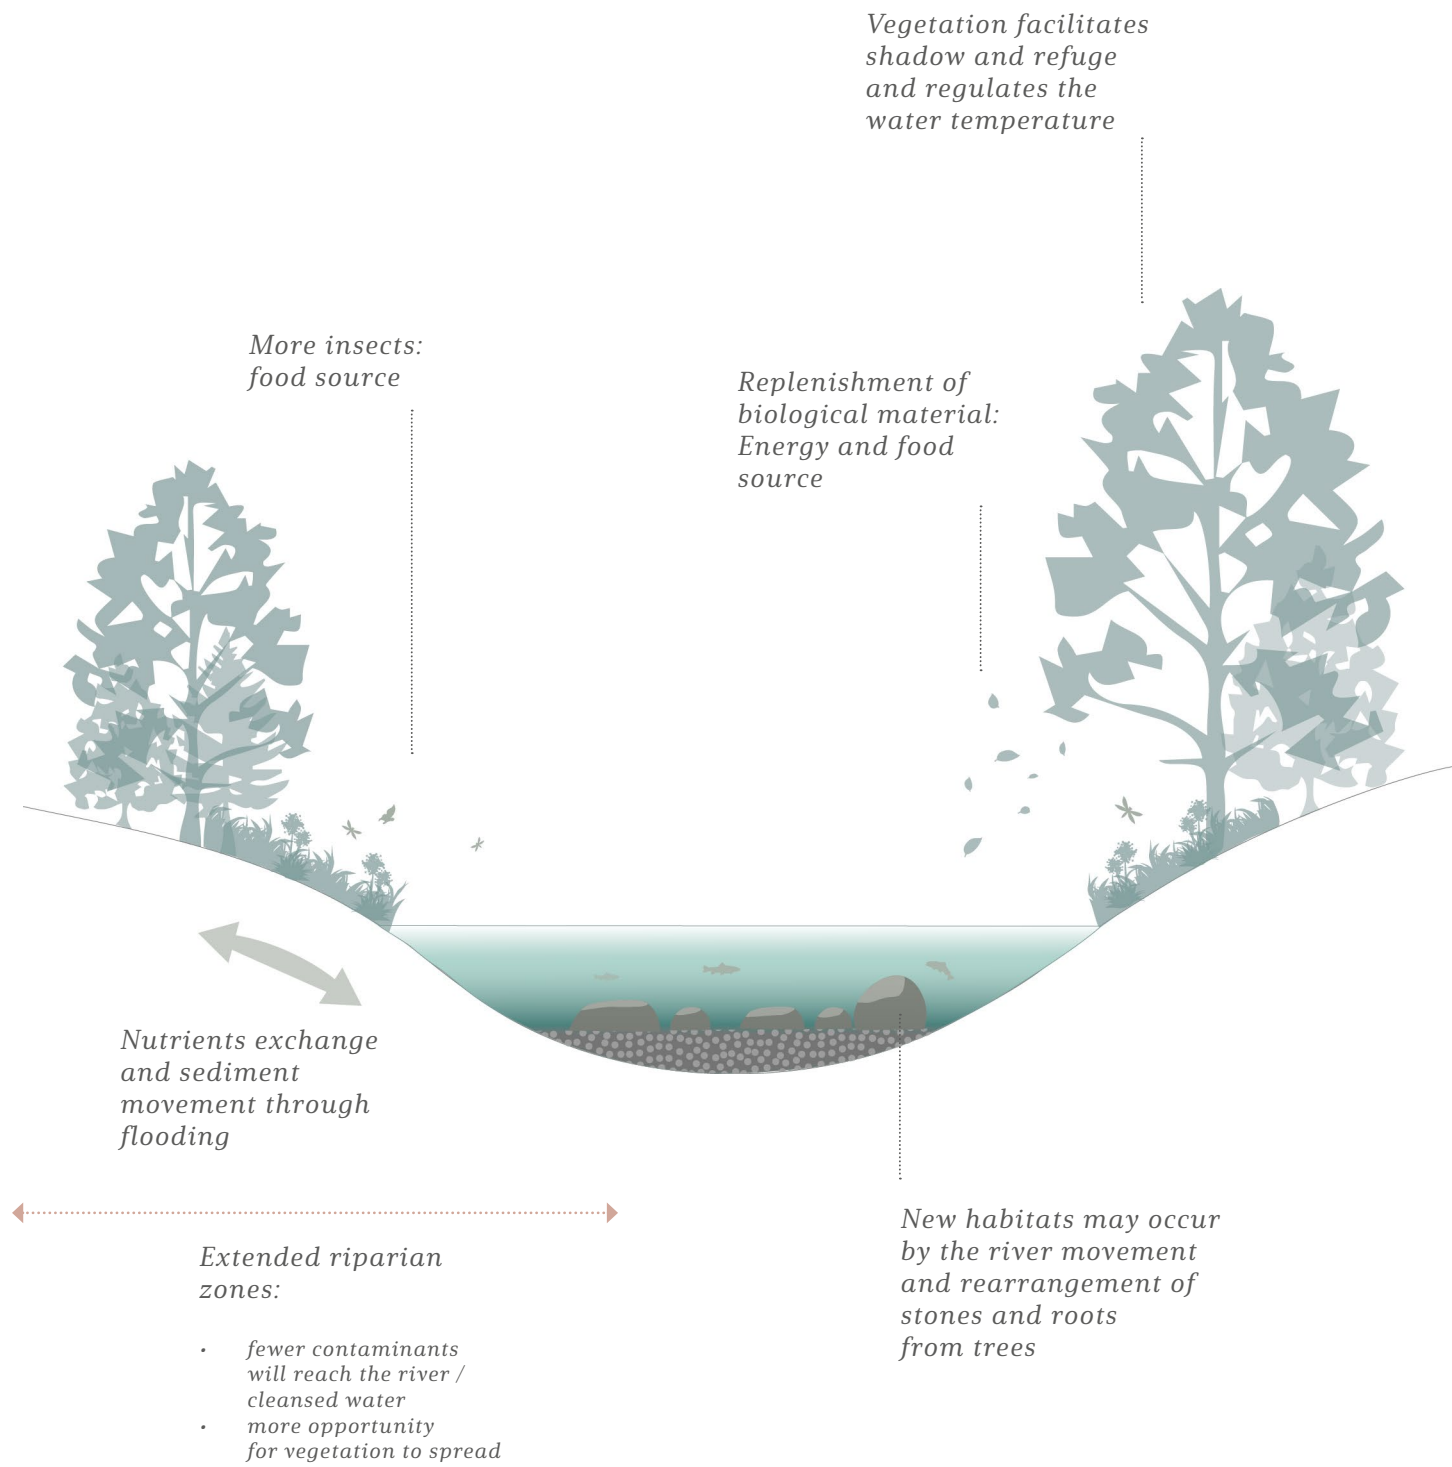
Figure 69c: Benefits for the trout and grayling (Illustration: Fjeldberg, I. 2022).

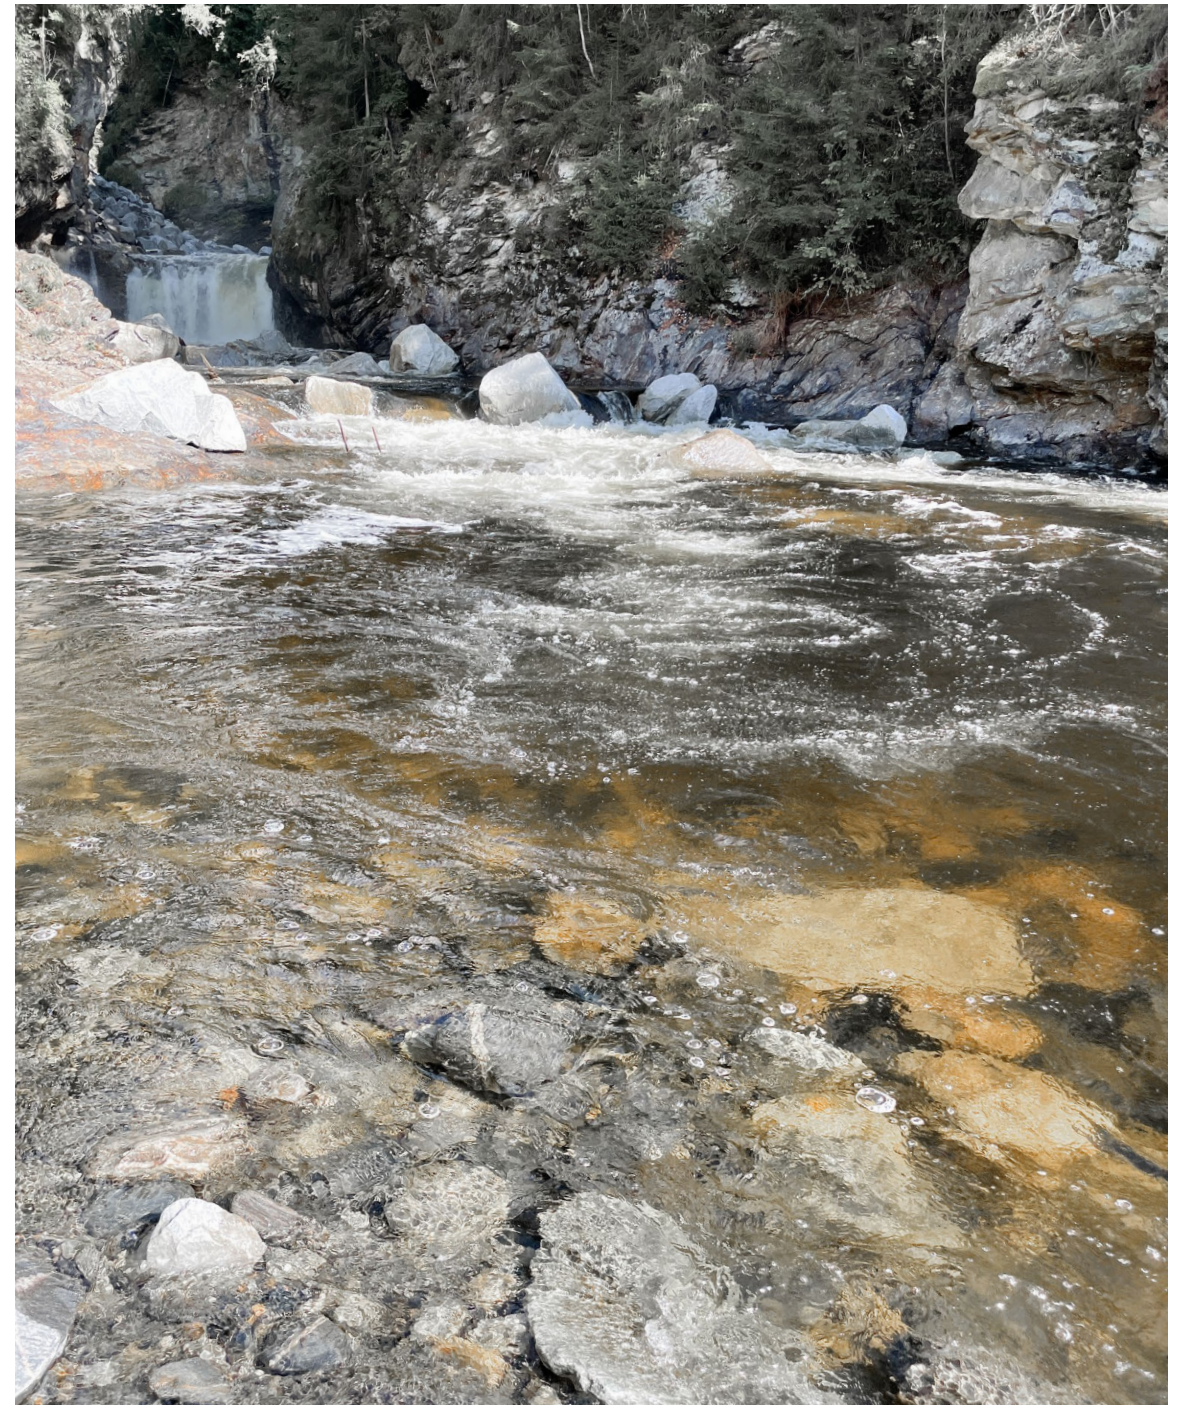
Figure 69d: The habitat pools are set to be reconstructed as part of the dam removal project (Photo: Fjeldberg, I. 2022).
