Norwegian University
of Life Sciences

Master's Thesis 2018 30 ECTS

Jakub Glanzer Synagogue: Strategy development for revitalization of historic buildings.

2 Chapter 2: Current condition of the building

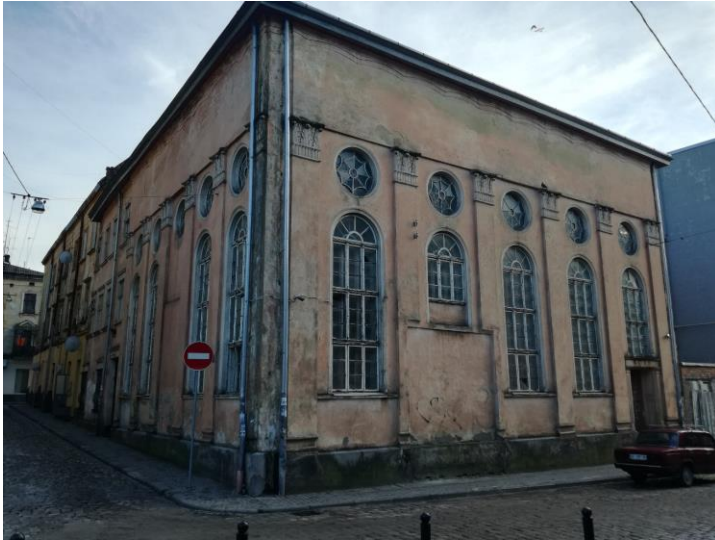
Figure 2-6: North facade. (Author, 2018).

During the second world war under the German occupation 1941-1944, the synagogue was taken over and used as a warehouse. To accommodate the flow of goods, a sizeable hole was made in the North façade under the second left window. It is clearly visible today (Figure 2-6). (Gelston, 2009).

The North façade facing St. Teodor's square is the most visually representative part of the building (Figure 2-6). Here are five ocular windows and five corresponding long windows. Two of the long windows are not of the same length. The second window to the left was halved to accommodate an opening for a truck entrance during the German occupation. The last window to the right is also halved to fit the entrance door underneath. We can also notice the motive of six pilasters. Another detail is the clean flat part of the wall right below the soffit.

Context Problem:	<i>Truck entrance (north)</i>		Reference:
<p>Attribute Analysis:</p> <ul style="list-style-type: none"> 1) Condition 2) Aesthetic 3) Historical Importance 4) Contextual 5) Social and Spiritual 	<p>The truck entrance is a unique symbol of the North façade. It represents the history of occupation the city went through. It has an important social and spiritual significance.</p>	<p>Figure: 2-5 2-6 B4</p>	
<p>Choosing an Alternative:</p> <ul style="list-style-type: none"> a) Preservation b) Rehabilitation c) Restoration d) Reconstruction e) Nothing* 	<p>Suggested action is <i>Rehabilitation</i>.</p>

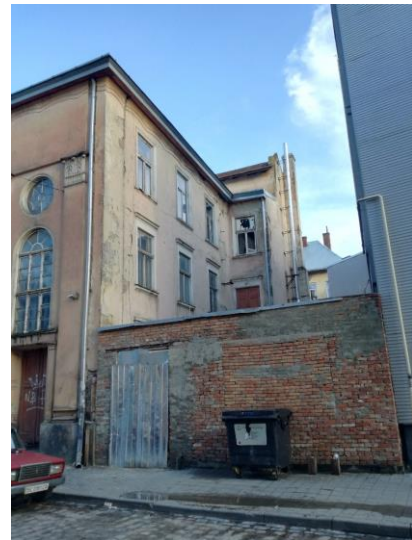
Figure 2-7: North entrance gate. (Author, 2018).

Next to the synagogue was a butcher's shop that sold kosher meat and an old entrance to the woman's galleries (Figure 2-7; Figure A4). Today the butcher's building is demolished, and the staircase leading to the galleries is dismantled. From an old photograph (Figure C35) it is known that there has been an original decorative entrance gate in place of the current metal sheet blocking the entrance.

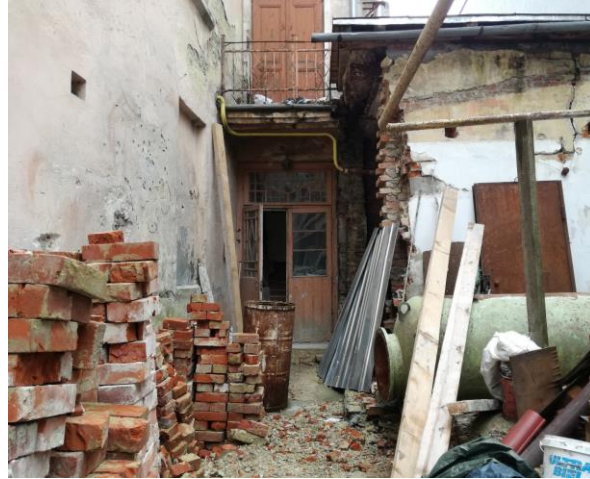
*Figure 2-19: Courtyard.
(Author, 2018).*

To give a perspective. The courtyard is a work in progress for the time being (Figure 2-18; Figure C13). The old butcher's shop is gone. Stairs leading up to the galleries are dismantled (Figure A4). What remains is the visible balcony and the old entrance. The boiler room with a furnace is strengthened after being damaged. It is visible directly on the right of the entrance to the synagogue (Figure 2-19). Behind it, there was a pathway going around the corner into the back. In the courtyard, there are some of the windows on the first floor that have been covered up with brick and plaster (Figure C10). As mentioned earlier, the entrance gate is replaced with a piece of metal sheet for the time being. Original gate is stored inside the prayer hall (Figure C15). The courtyard is not part of the evaluation in this thesis, however more pictures can be found in Appendix C.

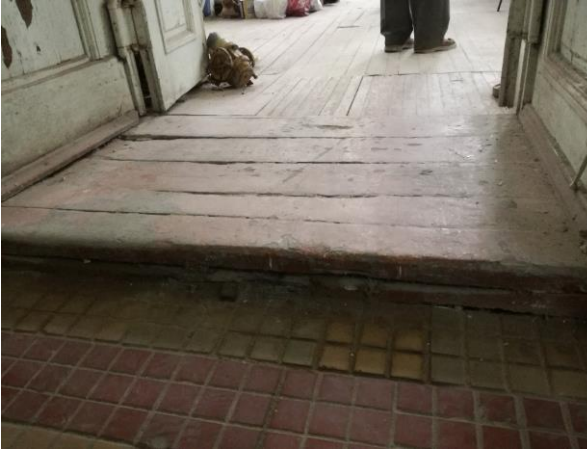
Figure 2-21: Entrance to the prayer hall. Floor transition detail. (Author, 2018).

Going to the right in the hallway is the prayer hall (Figure 2-20). The entrance has old wooden doors. A lot of the interior has been changed. First and foremost, the original paintings on the walls and the ceiling have been covered in oil paint. (Figure 2-23) Secondly, the floor has likely been replaced (Figure 2-21), as the entrance door has been trimmed at the bottom to fit the floor. (Figure C19). Thirdly, the main prayer hall is nowadays used primarily as storage (Figure 2-22), while other services like meetings and ceremonies take place in the multipurpose area on the second floor.

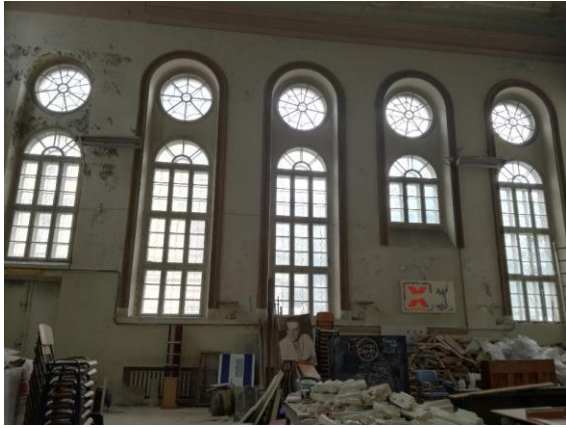
*Figure 2-24: Prayer hall. Northern wall.
(Author, 2018).*

The prayer hall has got 4 walls. The northern part (Figure 2-24) has got two sets of five windows, where two of the long windows are shorter than the rest. (see 2.5.1.1 Façade, North) The second window on the right has been shortened to accommodate an entrance for the trucks during the German occupation. The first window to the left is shorter. It provided light to the women galleries that have been dismantled to accommodate gym in the building. Underneath the window is a direct entrance to the prayer hall. Each of the windows is a double window with glass on the inside and the outside of the building. The long windows have got metal bars shaped in a wavy pattern in between the layers. (Figure C22). At the bottom below the windows, a niche has been made to make space for the old radiators (Figure C23).

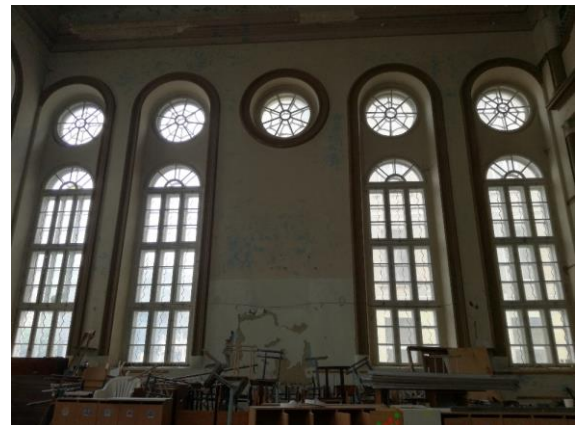
*Figure 2-25: Prayer hall. Eastern wall.
(Author, 2018).*

The eastern part is lacking one window (Figure 2-25). The rest is uniform with the northern wall. From Chapter 1 we know that “the niche of the altar cupboard was walled in”, possibly finding its place on that wall.

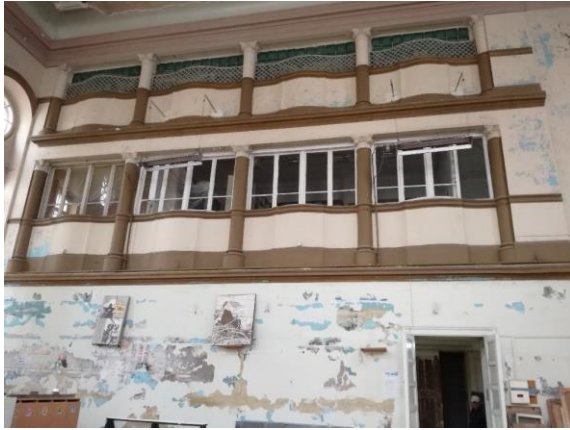
Figure 2-26: Prayer hall. Southern wall. Women galleries. (Author, 2018).

Going over to the southern part (Figure 2-26) Here are: the original women galleries, the entrance to the prayer hall and the damaged paintings, that stretch at least over the southern and the western part (the rest is yet to be uncovered) (Figure 2-27). The original galleries have not been covered with either windows or glass blocks. The look is quite simplified in comparison to the one known from the architectural drawings by Włodzimierz Podhordecki from 1912 (Figure A1; Figure A2). Unfortunately, it is impossible to say how much of the proposal has been implemented in the synagogue, and how much has been damaged during pogrom of 1918.

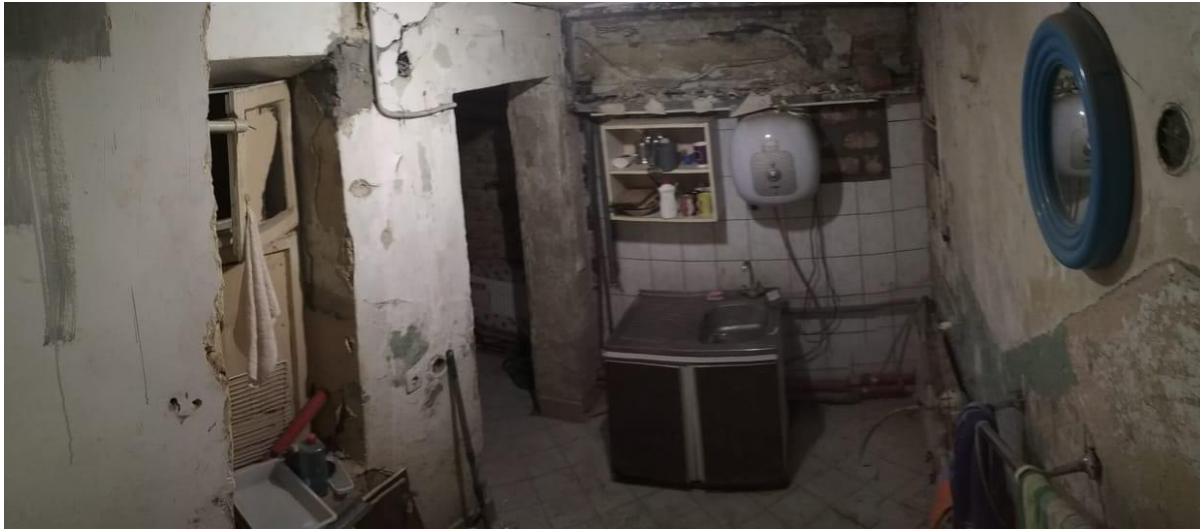
Figure 2-31: Toilets. General overview. (Nazar, 2018).

Entrance to the toilets is on the first half floor of the staircase (Figure C31). Stairs covered with tiles leading into the toilet. There is no handrail on the walls and no ramp or elevator for disabled people. Walls and ceiling are in a very poor condition (Figure 2-31). Many cracks and uncovered bricks, no paint job. The floor is laid with tiles and is in good condition. Inventory of the toilet is poorly equipped for public use. It is difficult to enter the toilet (Figure 2-32) through the angled wall. The room accommodates two toilet units and one faucet (Figure 2-33).

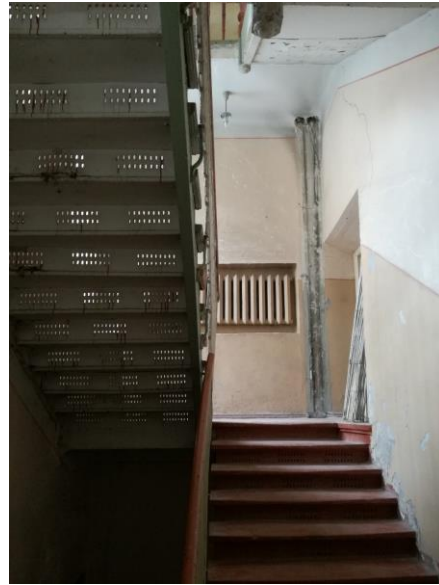
Figure 2-35: Staircase. Second half-floor
(Author, 2018).

The staircase is the only one in the whole synagogue. There is no elevator, and the staircase is not fire regulated. The construction of the staircase is made of steel frame with wooden elements. On each half-floor is a radiator (Figure 2-35). Old heating pipes have been removed (Figure C28). Walls in the staircase have been painted over. There are visible cracks on the walls. (Figure C29).

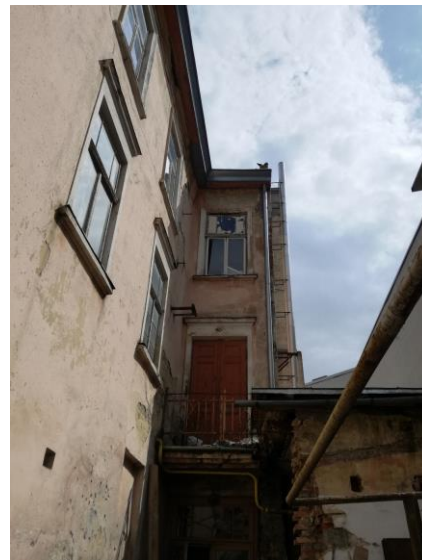
Figure 2-37: Courtyard. Remaining balcony after the dismantled stairs.
(Author, 2018).

The door on this half-floor (Figure 2-36) lead to an outside balcony (Figure 2-37) and to an entrance to the galleries on the first floor. Old stairs outside are dismantled (Figure A4).

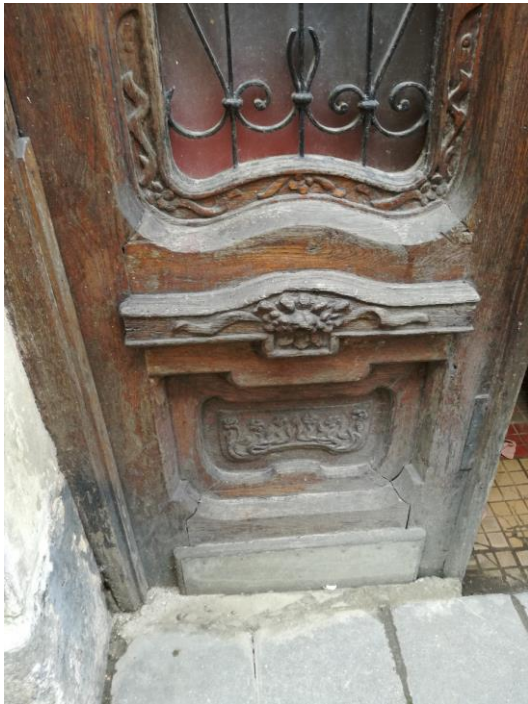
Figure C1: Main door detail. Flowers.
(Author, 2018).

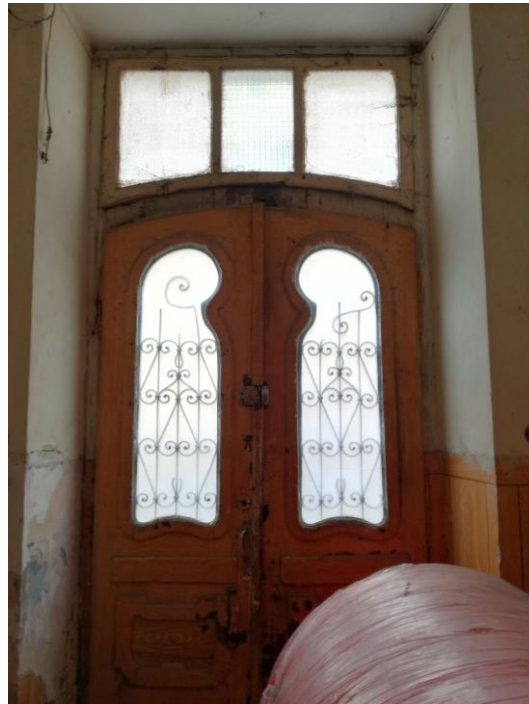
Figure C2: Main door. View from the inside.
(Author, 2018).

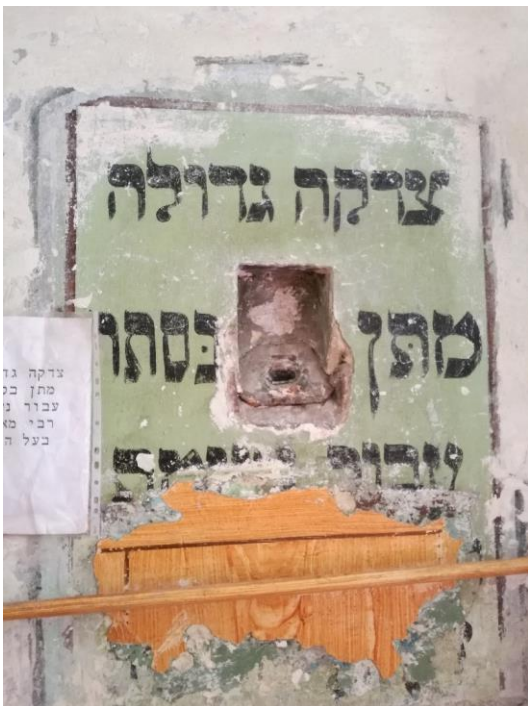
Figure C3: Painting by the entrance.
(Author, 2018).

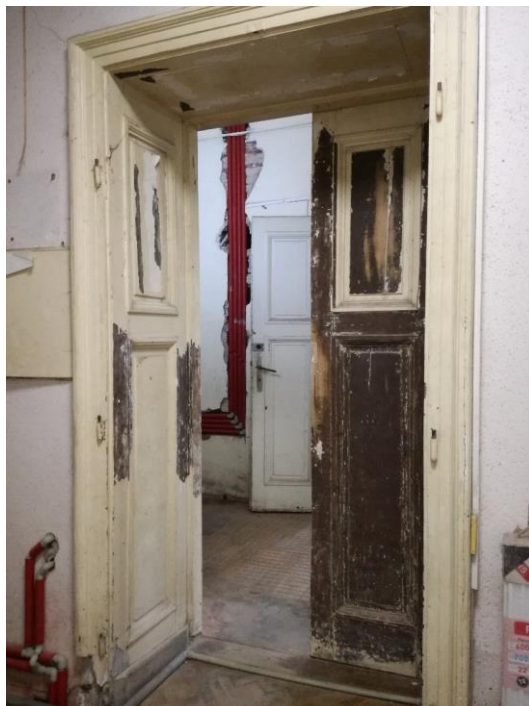
Figure C4: Side doors in the hallway. New heating system in the background. (Author, 2018).

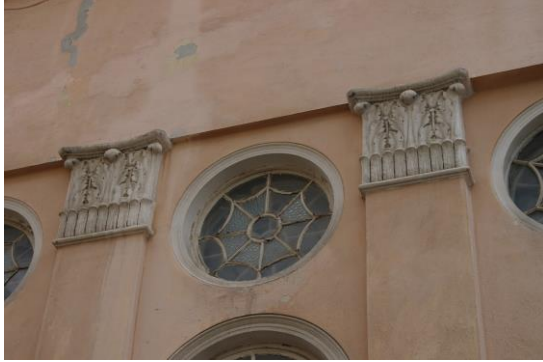
Figure C5: Pilaster detail. (Nazar, 2011).

Context Problem:	<i>Pilasters</i>		Reference:
<p style="text-align: center;">Attribute Analysis:</p> <ul style="list-style-type: none"> 1) Condition 2) Aesthetic 3) Historical Importance 4) Contextual 5) Social and Spiritual 	<p>The pilasters are in a similar condition to that of the walls. Ornaments at the top resemble flowers which is a recognisable detail for the Corinthian style. The pilasters have an ornamental and representative function.</p>	<p>Figure: 2-6 B4 C5</p>	
<p style="text-align: center;">Choosing an Alternative:</p> <ul style="list-style-type: none"> a) Preservation b) Rehabilitation c) Restoration d) Reconstruction e) Nothing* 	<p>Suggested alternative is <i>Rehabilitation</i>.</p>

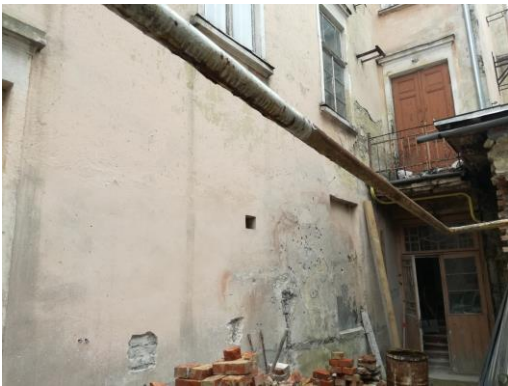
Figure C7: Western wall. Courtyard view. (Author, 2018).

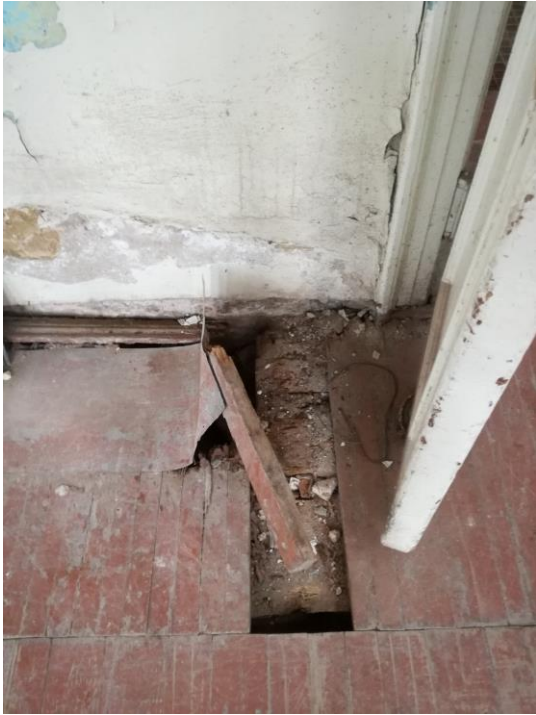
Figure C11: Prayer hall. Floor detail. (Author, 2018).

Context Problem:		<i>Floor</i>	Reference:
<p>Attribute Analysis:</p> <p>1) Condition</p> <p>2) Aesthetic</p> <p>3) Historical Importance</p> <p>4) Contextual</p> <p>5) Social and Spiritual</p>	<p>The floor is made of red and white tiles. They are worn down and the red tiles are placed in rectangular shapes. It is the only floor of that type in the synagogue. The usage indicates possible historical originality and importance. Some places the tiles are covered or missing. No specific social or spiritual relation.</p>	<p>Figure:</p> <p>2-12</p> <p>C4</p> <p>C7</p>	
<p>Choosing an Alternative:</p> <p>a) Preservation</p> <p>b) Rehabilitation</p> <p>c) Restoration</p> <p>d) Reconstruction</p> <p>e) Nothing*</p>	<p>The floor is well conserved, so no need of replacing it. The suggested action here would be <i>Rehabilitation</i>, to remove the material covering the tiles and add any missing ones.</p>

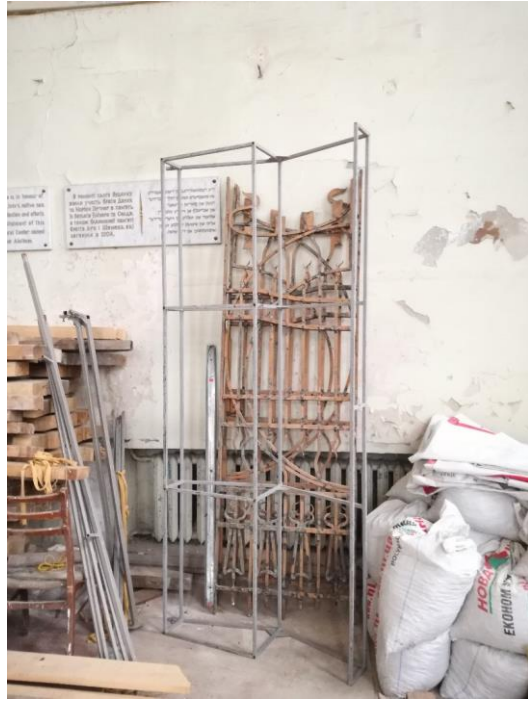
Figure C12: Northern entrance gate doors. (Author, 2018).

Context Problem:	<i>Entrance gate (north)</i>		Reference:
<p>Attribute Analysis:</p> <p>1) Condition</p> <p>2) Aesthetic</p> <p>3) Historical Importance</p> <p>4) Contextual</p> <p>5) Social and Spiritual</p>	<p>The original gate has been taken down and stored in the synagogue. After demolishing of the butcher's shop, a new wall had to be put up. The wall is made of bricks, and the entrance gate is replaced with a metal sheet.</p> <p>The wall should be uniform with the rest of the Northern façade for a complete visual effect of the Northern façade. Also, to regain its functionality as an alternative entrance/exit to the synagogue.</p>	<p>Figure:</p> <p>2-7</p> <p>B4</p> <p>C10</p> <p>C12</p> <p>C35</p>	
<p>Choosing an Alternative:</p> <p>a) Preservation</p> <p>b) Rehabilitation</p> <p>c) Restoration</p> <p>d) Reconstruction</p> <p>e) Nothing*</p>	<p>Suggested action is <i>Restoration</i>.</p>

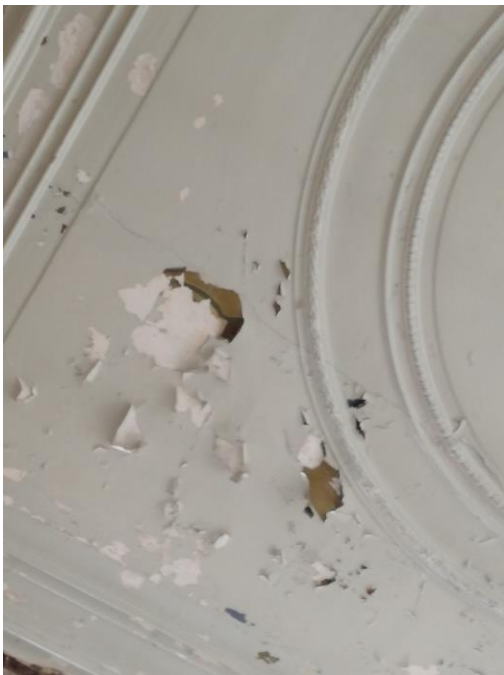
Figure C13: Prayer hall ceiling. Covered painting. (Author, 2018).

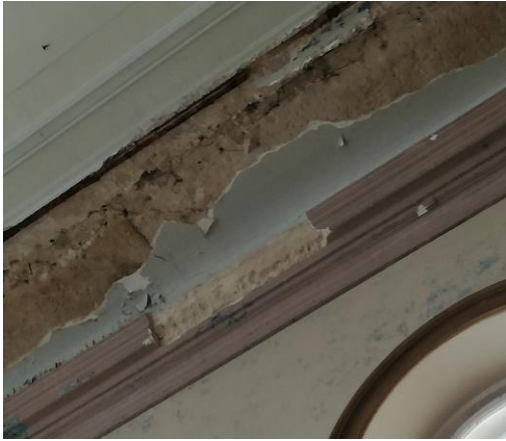
Figure C15: Prayer hall. Ceiling over the windows. Northern wall. (Author, 2018).

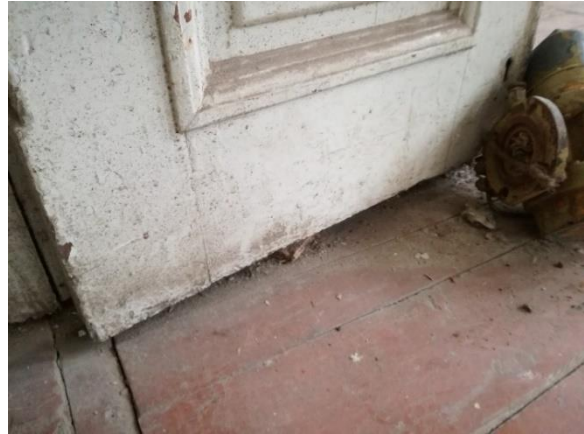
Figure C16: Trimmed door to the prayer hall. (Author, 2018).

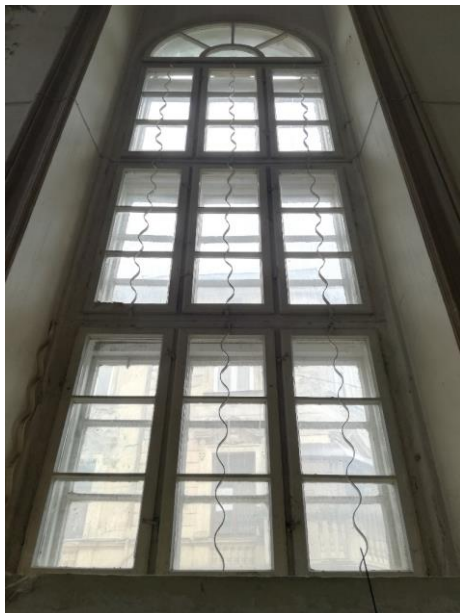
Figure C19: Long window detail. Prayer hall. (Author, 2018).

Context Problem:	<i>Long windows</i>		Reference:
<p>Attribute Analysis:</p> <ul style="list-style-type: none"> 1) Condition 2) Aesthetic 3) Historical Importance 4) Contextual 5) Social and Spiritual 	<p>Similarly, to the ocular windows. The frame is wooden, and the paint is coming off the windows. The top of the windows has a half circular shape. Two of the windows are shorter than the rest. They are covering most of the northern and eastern façade walls and are very characteristic for the building.</p>	<p>Figure:</p> <ul style="list-style-type: none"> 2-5 2-6 B4 C19 	
<p>Choosing an Alternative:</p> <ul style="list-style-type: none"> a) Preservation b) Rehabilitation c) Restoration d) Reconstruction e) Nothing* 	<p>The windows are in a good condition and have a representative value. Suggested action is <i>Rehabilitation</i>.</p>

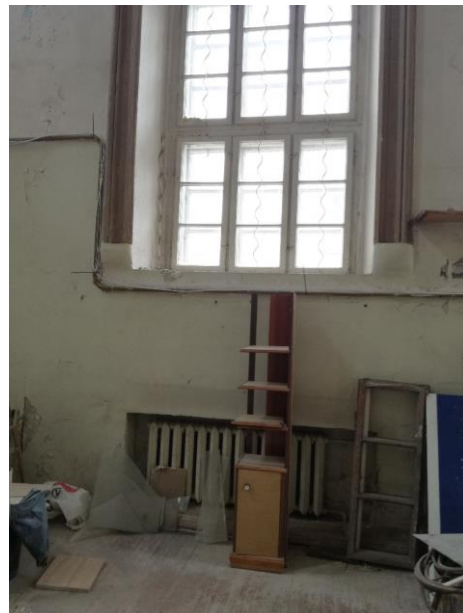
Figure C20: Radiator niche underneath the long window. (Author, 2018).

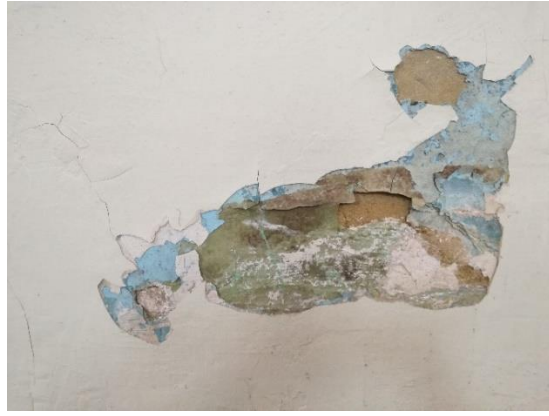
Figure C22: Three layers of paint. Prayer hall. (Author, 2018).

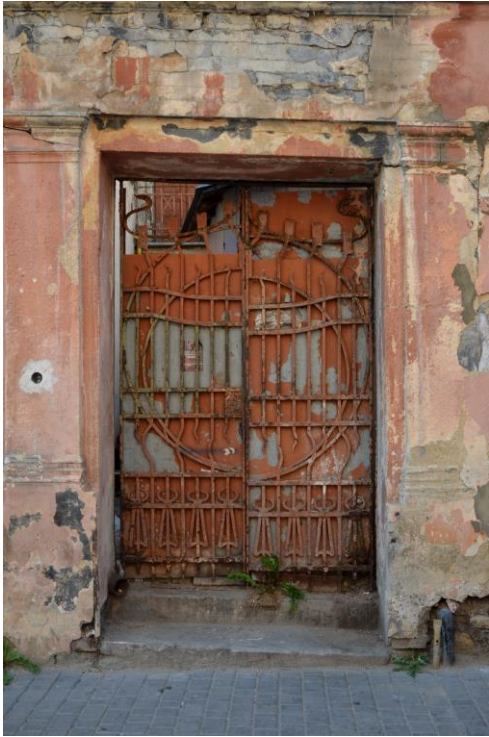
Figure C35: Old entrance gate. (Nazar, 2011)
